Temperature Improvement Project
Tangentyere Council Inc.
Sponsored by Virgin Unite

Data Analysis from Temperature & Power Monitoring Equipment $1\,2^{\,t\,h}$ of September $2\,0\,1\,1$: HEALTHABITAT

Temperature Improvement Project

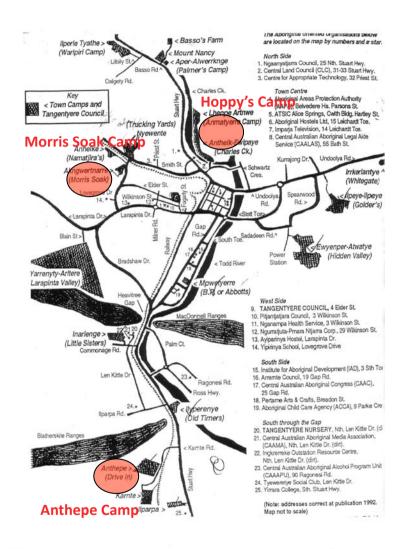
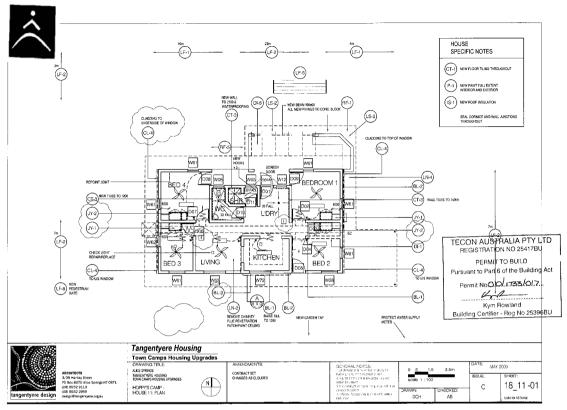
House TAN1

House Tan 1 before thermal upgrades west elevation

House Tan 1 after thermal upgrades west elevation. New shade wall, new ducted evaporative cooling system, new pergola roof to north

4 bed single storey concrete block, slab-onground, verandah to 2 sides, no thermal upgrades prior to current project

New works affecting thermal performance: (not full scope of works) Passive heating & cooling

- new roof insulation
- new shade wall (new colorbond cladding on battens with aircell behind to underside of windows to west & east - above windows as well to east)
- •new roof cladding to pergola to north
- seal cornice & wall junctions throughout
- new paint full extent interior & exterior
- new floor tiling throughout
- new screen door, new external front door
- new windows throughout
- repair/ new fence/ new pedestrian gates etc.(yard works)

Active heating & cooling

- new ducted evaporative cooling system4 new ceiling mounted fans
- new ceiling mounted radiant heaters in bedrooms, kitchen & living (6 total)

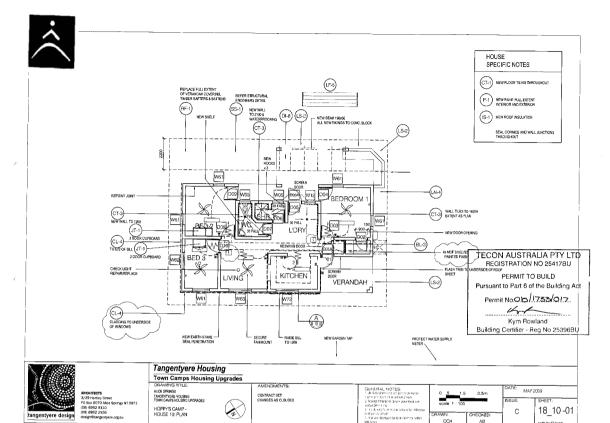
House TAN2

House Tan 2 before thermal upgrades

House Tan 2 after thermal upgrades new evaporative cooling system, new shade wall

3 bed single storey concrete block, slab-onground, verandah to 2 sides, no thermal upgrades prior to current project

New works affecting thermal performance: (not full scope of works)

Passive heating & cooling

- new roof insulation
- new shade wall (new colorbond cladding on battens with aircell behind to underside window to north east & north west wall)
- •new verandah covering, timber rafters & battens
- seal cornice & wall junctions throughout
- new paint full extent interior & exterior
- new floor tiling throughout
- new screen doors
- new windows throughout

Active heating & cooling

- new ducted evaporative cooling system & 3 new ceiling mounted fans
- new ceiling mounted radiant heaters in bedrooms, kitchen & living (5 total)

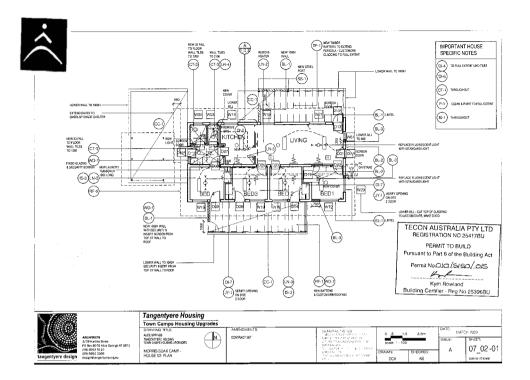
House TAN3

House Tan3 before thermal upgrades

House Tan3 after thermal upgrades

4 bed single storey concrete block, slab-on-ground, verandah to 3 sides including new thermal upgrade shade structure to west, wall shade to north & east as part of previous temperature control project

New works affecting thermal performance: (not full scope of works)

Passive heating & cooling

- new roof insulation
- existing pergola- (previous temperature control project) new slab, wall lowered
- new low wall to south external area, security insert from top of wall to roof, new slab, new customorb roof lining
- north external area- new timber rafters to extend pergola, customorb roof, new low wall
- lino tiles to full extent
- Repair/ replace cornice
- clean & paint to full extent
- New crimsafe security screens where indicated
- new ceiling insulation & new panelrib lining to bedrooms
- new/ repaired blockwork where indicated
- repair or replace external doors, new screen doors where indicated
- new windows. lower some window sills
- remove heater in living room

Active heating & cooling

- new ducted evaporative cooling system, 4 existing ceiling fans retained
- new ceiling mounted radiant heaters in bedrooms, kitchen & living (7 total)

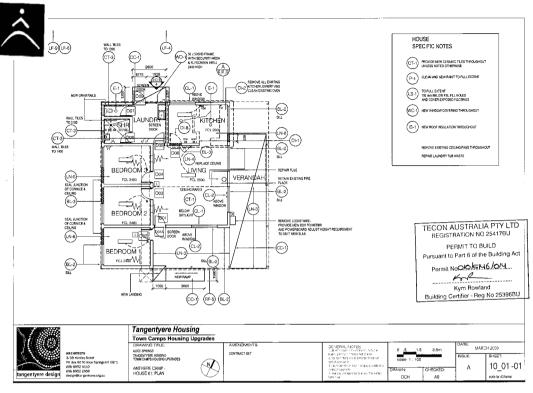
House tan4 before thermal upgrades

House Tan4 after thermal upgrades

4 bed single storey concrete block, slab-onground, verandah to 2 sides, thermal upgrade window awnings to north & west, wall shade to west as part of previous temperature control project

New works affecting thermal performance: (not full scope of works)

Passive heating & cooling

- new roof insulation throughout
- existing shade wall & awning to north & west walls part of previous temp. control project
- •provide new ceramic floor tiling throughout
- clean & new paint to full extent
- new window covering throughout (canvas curtains)
- •seal cornice & wall
- new screen doors
- new windows throughout
- new verandah slab to east
- replace fc sheet ceiling lining in living room
- repaired wall cladding
- replaced drainage pit for tap- (yard woks)

Active heating & cooling

- new ducted evaporative cooling system
- remove existing ceiling fans throughout
- new ceiling mounted radiant heaters in bedrooms, kitchen & living (5 total)
- •retained existing fireplace in living room & repaired flue

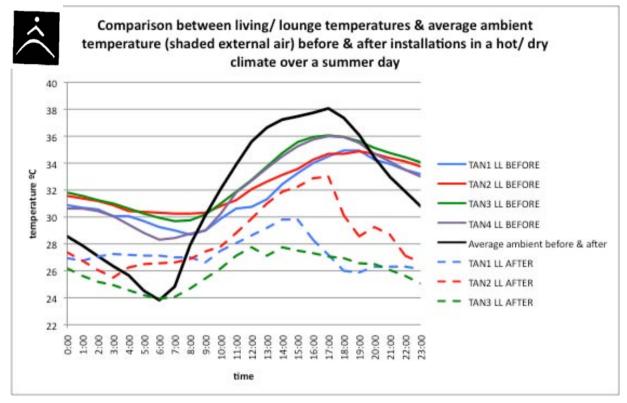
Three of the four houses had data available before & after thermal upgrade works

Data Analysis-summer
All 3 houses are showing significant
temperature improvement after
thermal upgrades.

House TAN3 showed the most improvement- up to 9°C cooler before than after thermal upgrades. Ambient temperatures ranged from 24°C to 38°C. House TAN3 ranged from 30°C to 36°C before and 24°C to 28°C after thermal upgrades.

Thermal upgrade works included passive (non energy using) & active (energy &/ or water using) heating & cooling. See pages 2-5 for a description of works. It is essential to make passive modifications to houses before active modifications. See page 9 for a discussion of energy use by active cooling systems in summer.

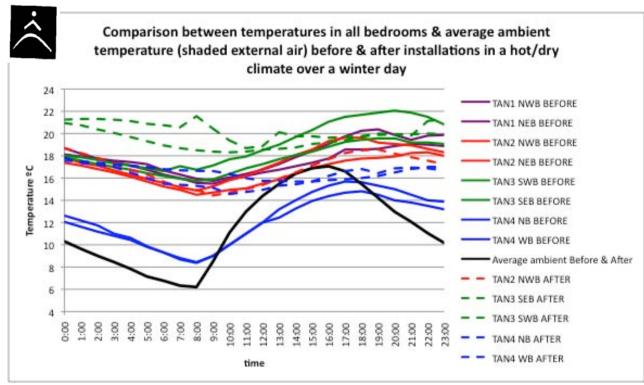
Three of the four houses had data available before & after thermal upgrade works

Data Analysis-winter All 3 houses are warmer than ambient temperatures after thermal upgrades.

House TAN4 is showing the most temperature improvement (max. 8°C). Internal temperatures follow ambient 8.5°C to 16°C before & are 15.5°C to 16.5°C after thermal upgrades. The temperature range has significantly narrowed.

House TAN3 is also warmer after thermal upgrades. TAN2 has similar temperatures before & after thermal upgrades.
See page 10 for a discussion of energy use by active heating systems in winter.

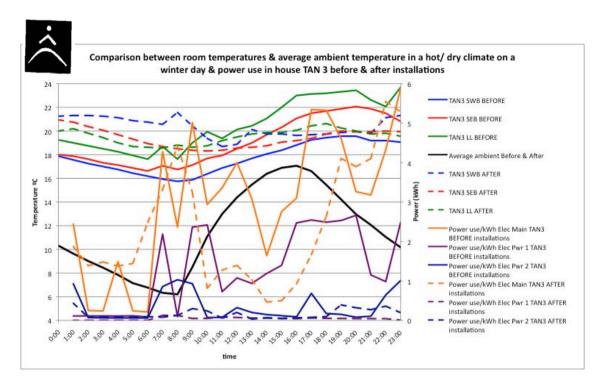
new ceiling mounted radiant heaters in bedrooms, kitchen & living, new evaporative cooling system ducting, existing ceiling fan

Tan3 existing in-window reverse cycle (heating & cooling) air conditioning systems x4 before thermal upgrades (removed after installation of new cooling system)

Data Analysis- temperature & power use in winter in one house House TAN3 is warmer overnight (max. 6°C) with LESS power being used after thermal upgrades than before, in winter. Temperatures are warmer in the early evening (max. 2°C) before than after thermal upgrades.

Total energy used in the house over a winter day (not just for heating): Before thermal upgrades=69kWh/day (included 4 in-wall reverse cycle air conditioning units)

After thermal upgrades= 55kWh/day (included new ceiling mounted radiant heaters in bedrooms, kitchen & living (7 total) with 8 hour timed cut off switch) This is a decrease from \$14.10/day to \$11.20/day for total electricity costs for the house after thermal upgrades.

Radiant heaters use significantly less power than reverse cycle air conditioners for winter heating. A greater difference in power use is not seen after thermal upgrades compared to before because existing a/c units may have not been working & the houses are being used more due to the upgrades.

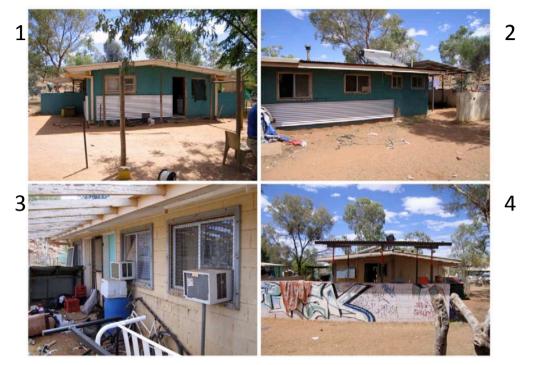
1] east façade with wall shade; 2] north façade with wall shade; 3] south façade with portable AC units; 4] west façade with shade structure & logger basestation installed at meterbox

Before thermal upgrade works

After thermal upgrade works
