**Report on the upgrading works of toilets, water
and drainage points in Diepsloot, Johannesburg
April 2015 and planning for future upgrade
works.**

**WASSUP, Sticky Situations,
WorldSkills Foundation, IAPMO and Healthabitat**

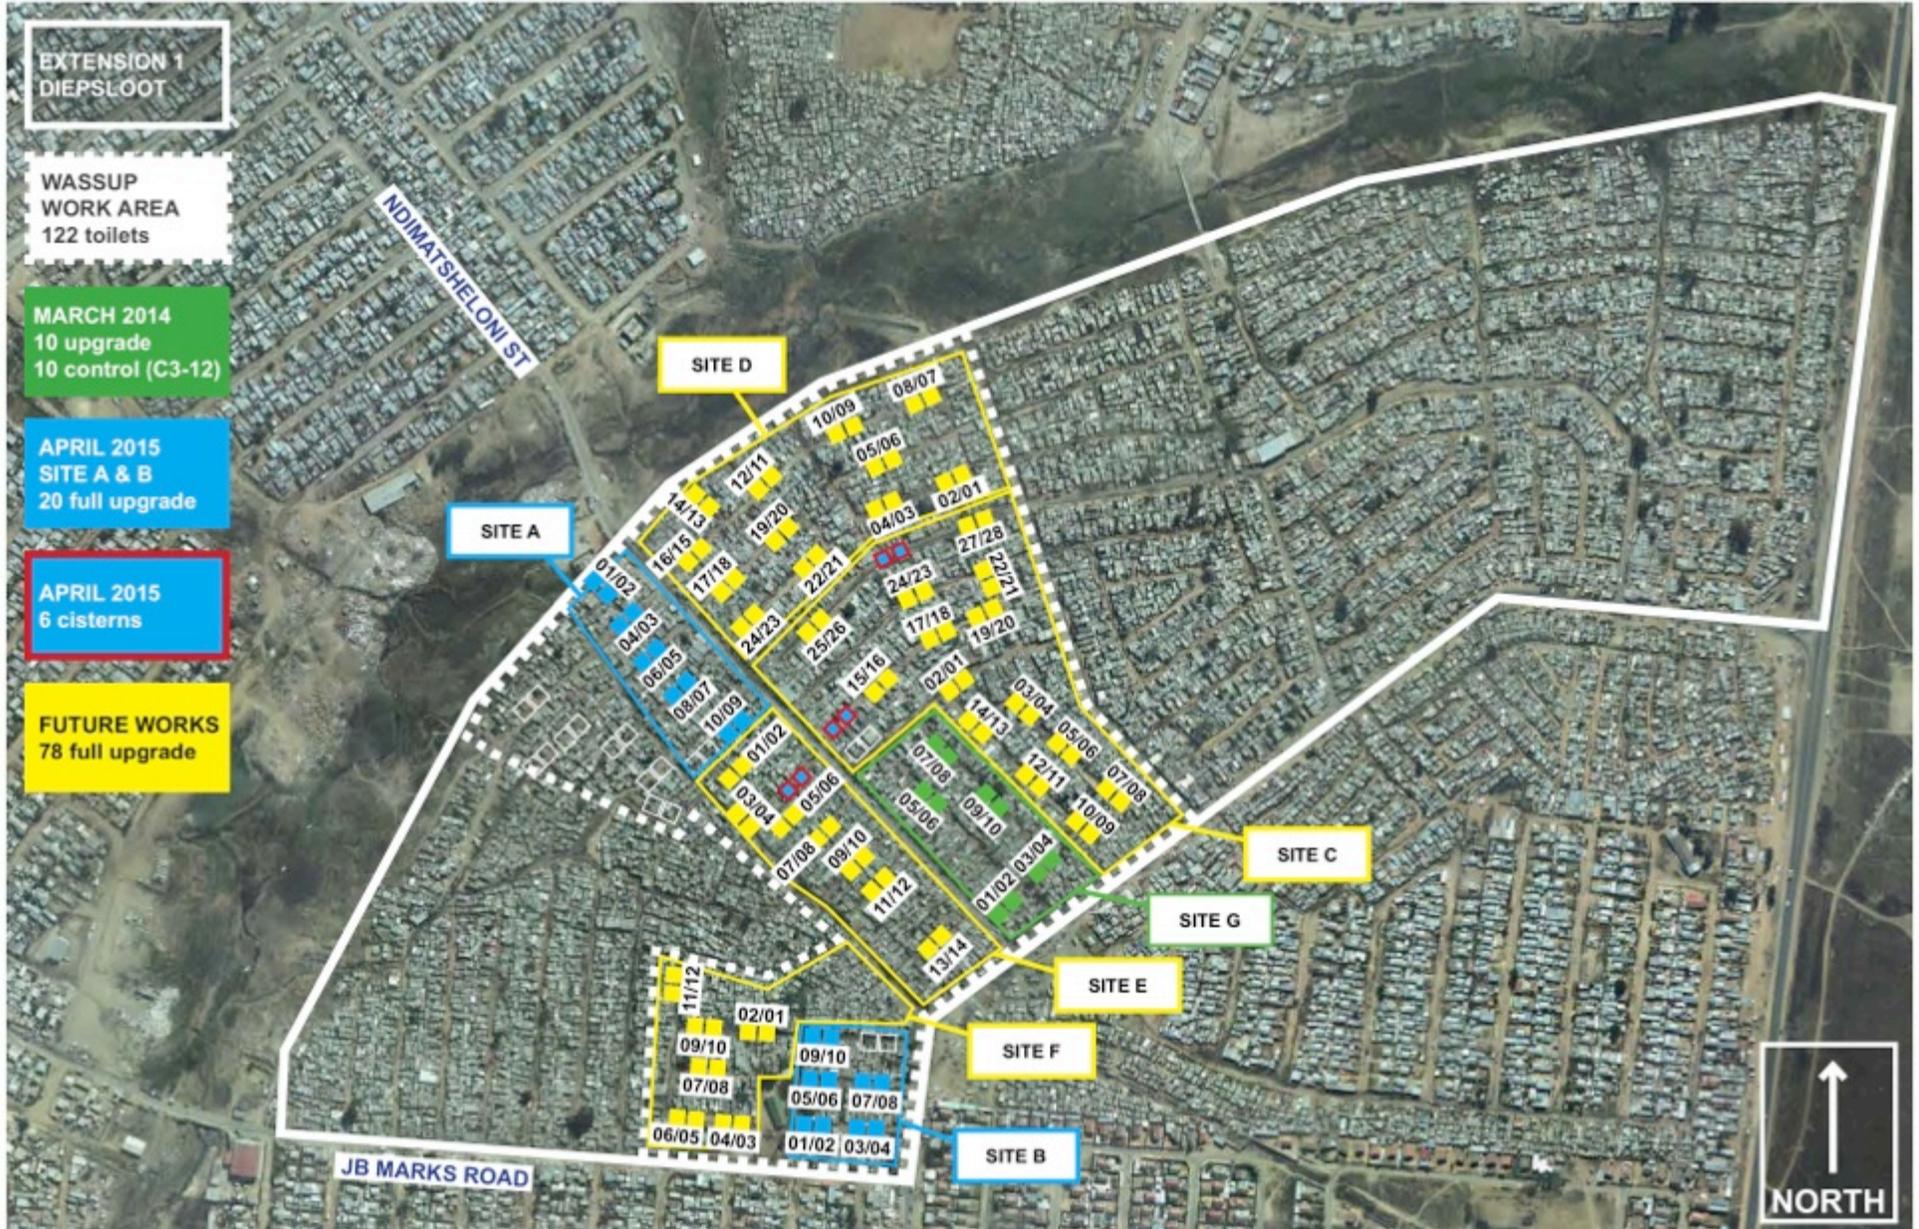
DIEPSLOOT Extension 1: WASSUP/ Healthhabitat/ World Skills Foundation works area

The alternative to the slow, grinding work of the WASSUP team upgrading and then maintaining toilets, water supply points and wastewater disposal points – lack of working facilities and rivers of sewage, wastewater, and illness.

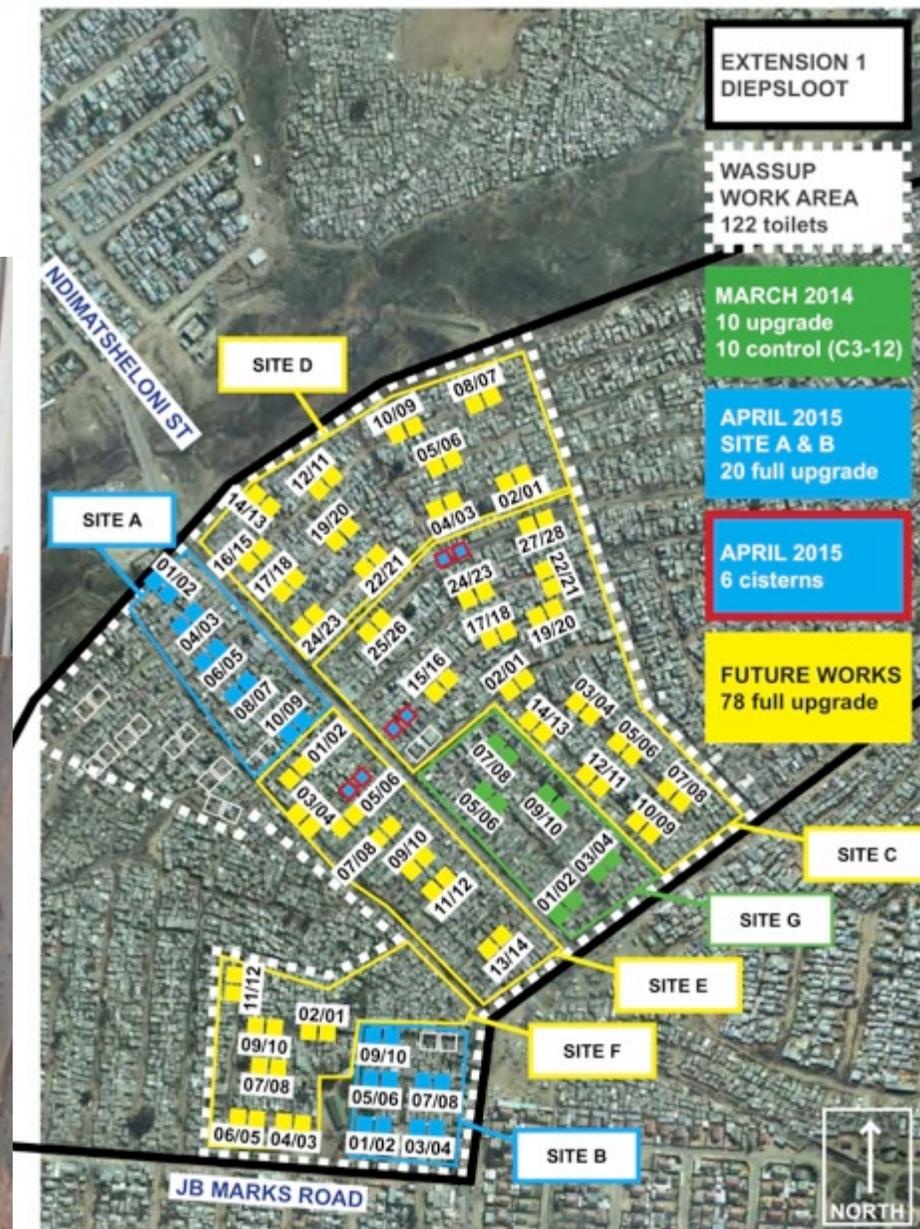
DIEPSLOOT Extension 1: WASSUP/ Healthabitat/ World Skills Foundation works area

Assessing toilet, water supply and drainage performance and population numbers using the facilities

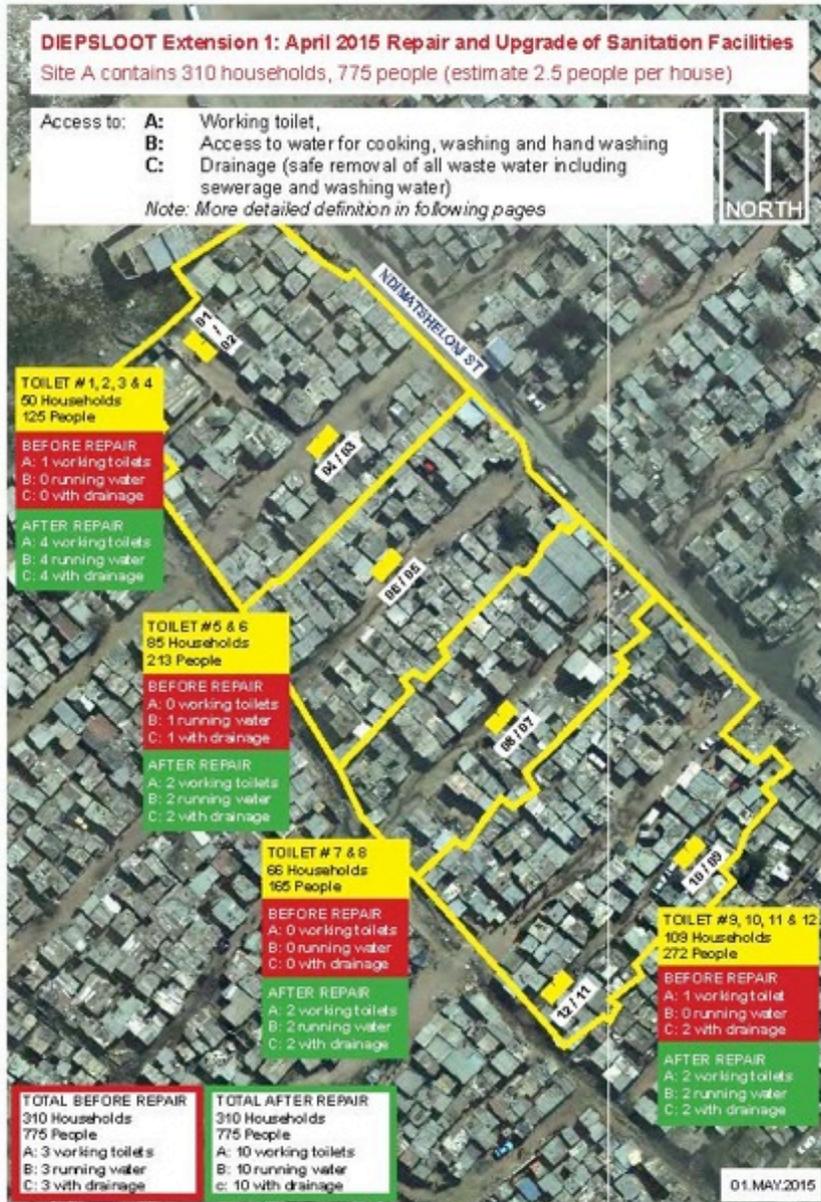
All 3 of the items (A, B, C) are essential for health, but prior to repair not a single location had all 3 items in full working condition.

Assume the population of approx. 795 are using 10 toilet units (toilets 11 and 12 were not functioning before or after the works).

In the area shown (left) :

125 people use 4 toilets but if only 1 toilet is working= 125/toilet

213 people use 2 toilets but if 0 toilets are working = 213 people have to use other toilets

185 people use 2 toilets but if 0 toilets are working = 185 people have to use other toilets

272 people use 2 toilets if 2 toilets are working= 136/toilet

If you assume the 213+185 people who had no access to a working toilet stayed within the area shown, then the load on the 3 working toilets and water / drainage points is now 795 people = **265 people per toilet.**

Given most access to toilet and water occurs between 6am and 8pm (2014 use data) this would mean use by **18 people an hour for 14 hours**, increased use will occur during morning and evening peaks.

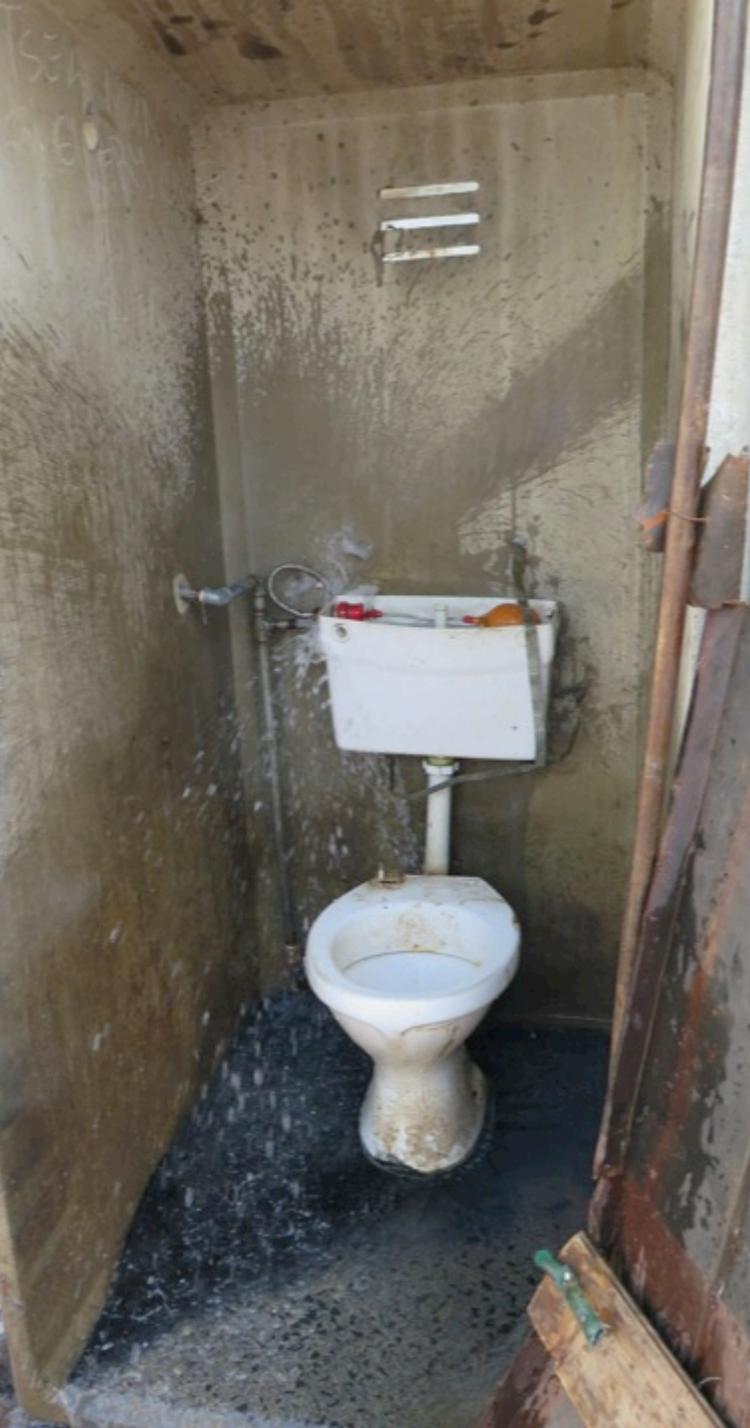
Data loggers

In 2014, water meter readings (*bottom left*) and data logging of cisterns (*top left*) was carried out to show the number of flushes, and overall water use. This work showed consistently high use of the facilities and the potential for water saving, not by reducing access to water or toilets, through the reduction of existing leaks.

After upgrading works fixed leaks, water savings consistently averaged 4,000 litres per toilet per day compared to metered, unmodified toilets and taps used as a control.

Given the solid data obtained in 2014, and the similar nature of the facilities found this year (*see example of a toilet leak left*) during the 2015 works only 2 new meters were fitted, one in each main area where works were completed.

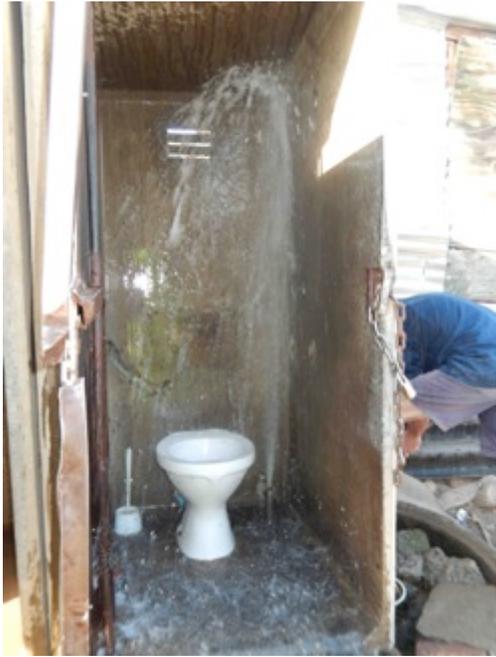
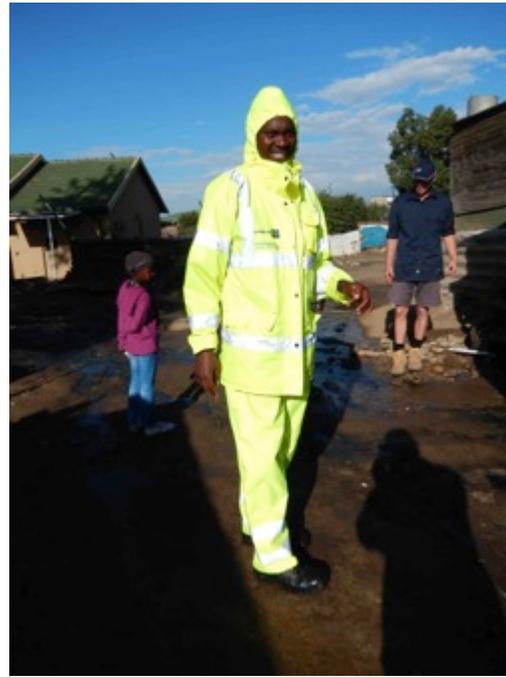
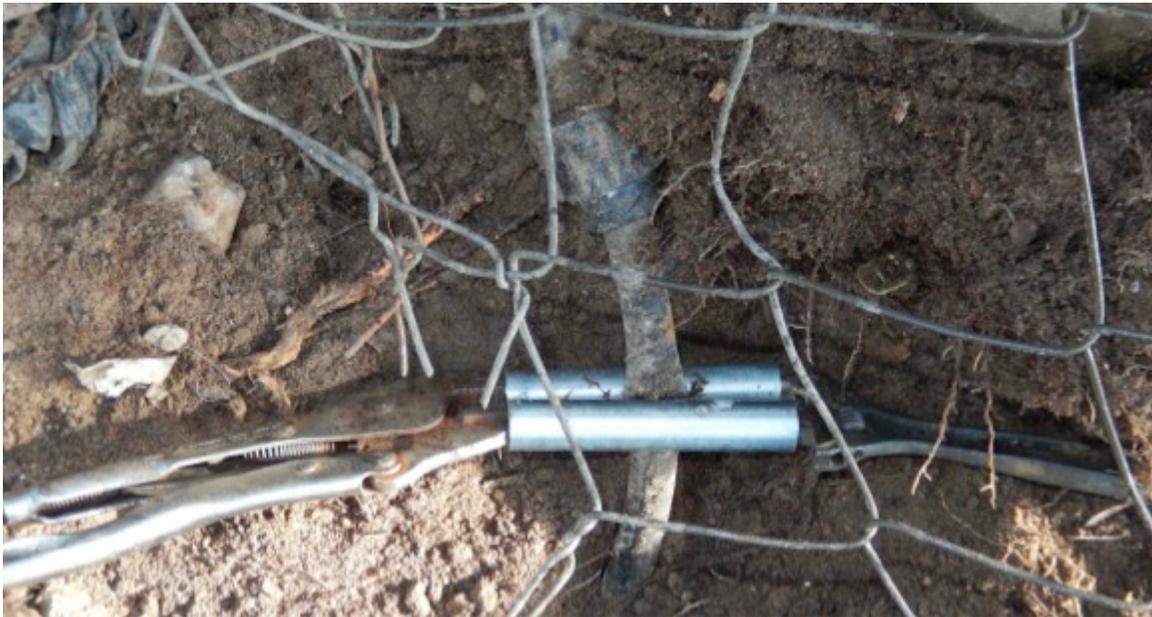
Pre work

New isolation valves are essential to control water for maintenance.

Adding these valves requires either;

- The main water supply being disconnected (by Joburg Water)
- Wet installation
- Crimping of the main supply temporarily to allow the fitting of the isolation valve

The problem (*top left*)

A WASSUP member gets ready for the wet install option (*top right*)

Crimping of the main polypipe supply line, using offcuts of water pipe and spanners, was the chosen method. (*bottom left*)

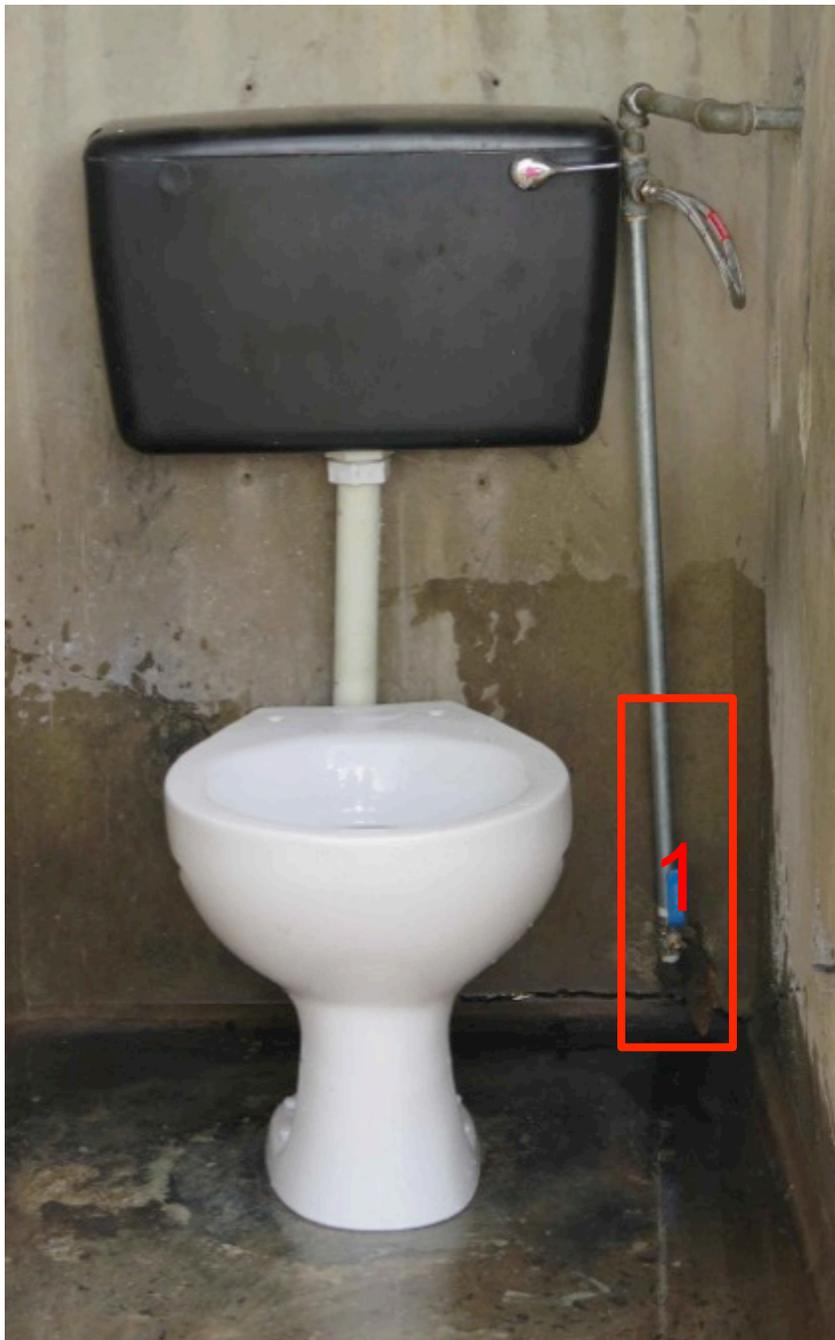
Work packages

1 Install new isolation (stop) valve on main water supply line with NO water meter + ext. tap

1a Install new isolation (stop) valve on main water supply line with water meter + ext. tap

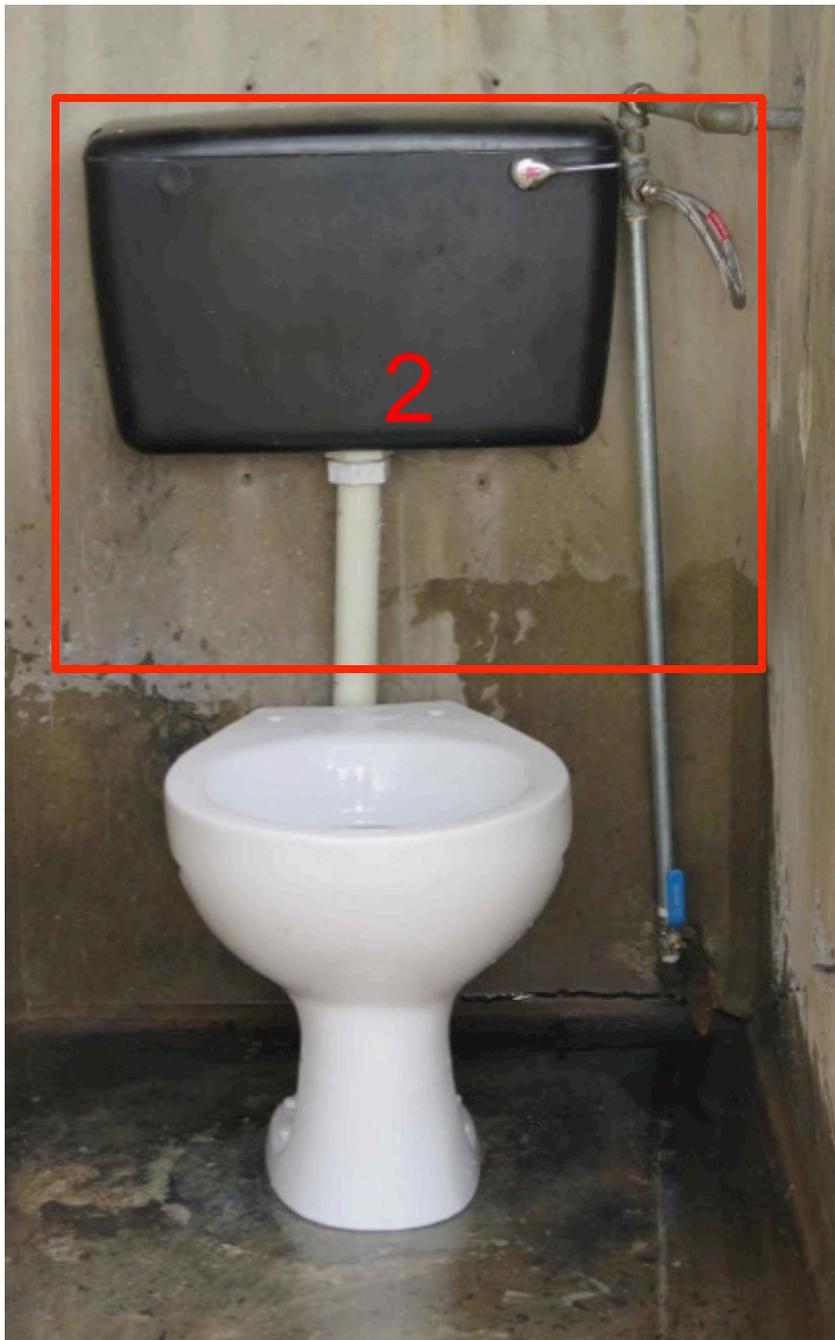
Work packages

2 Install new cistern, stainless flexible supply connection and flush pipe to suit pan

Branch to the cistern

Cistern and connection

Heavy duty black plastic cistern

1 3/4" semi close couple flush pipe OR to suit installation

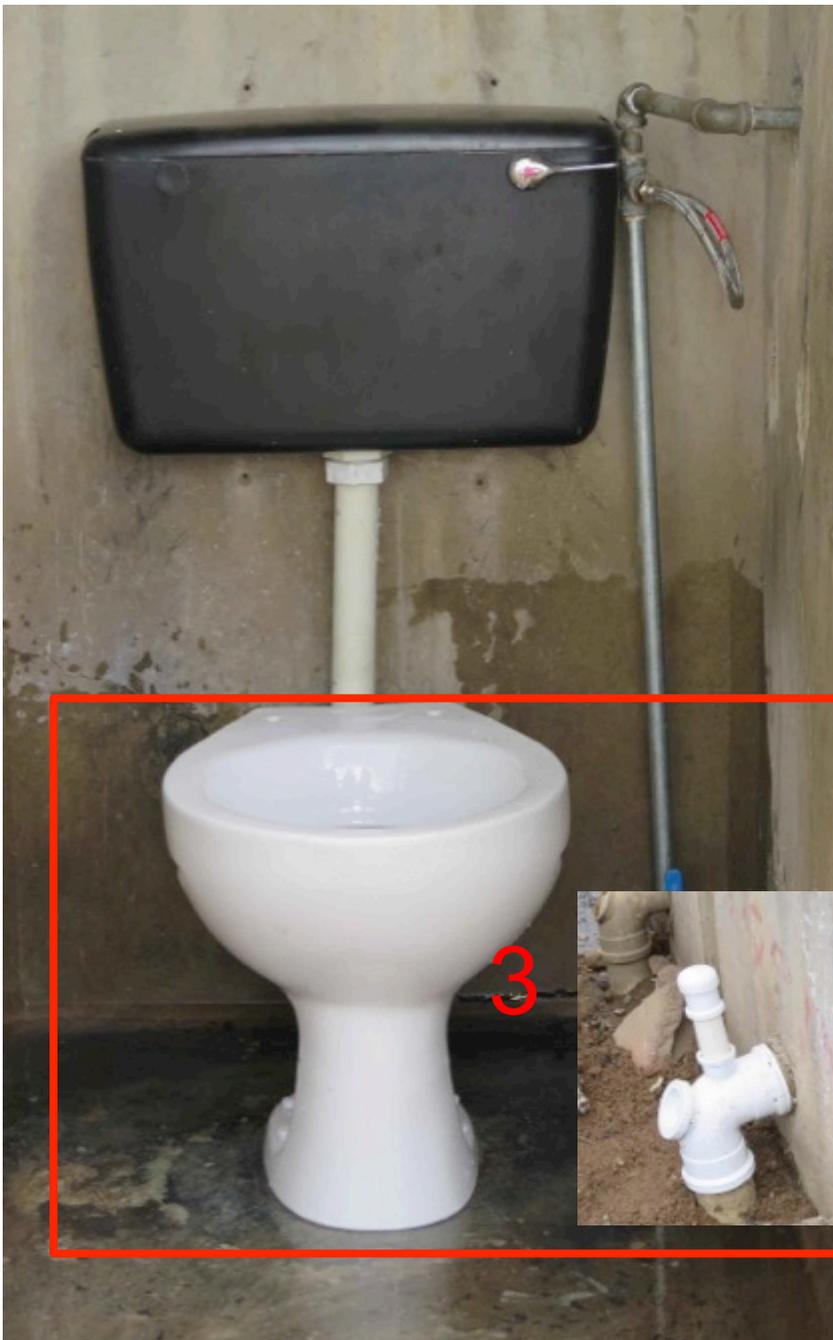
Work packages

3 Install new pan and waste pipework

WC waste system

Pan

110 mm pan adaptor

SV bend with horn 110mm 87.5 deg access heel

SV 50mm 2 way vent valve

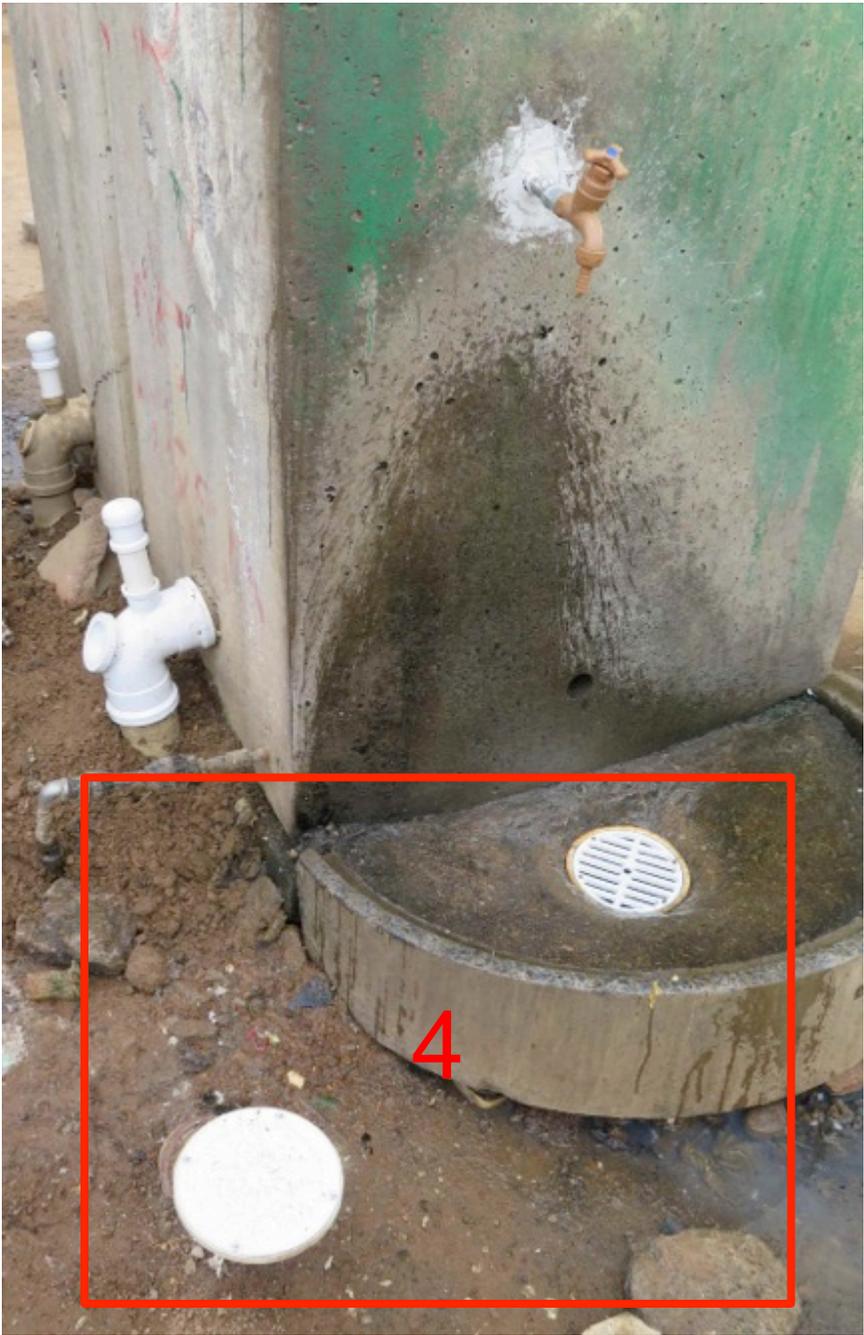
Work packages

4 Grey water waste drainage (basic fix)

Grey waste water

Gully grate (plastic)

110mm x gully grate adapter

110 gully trap

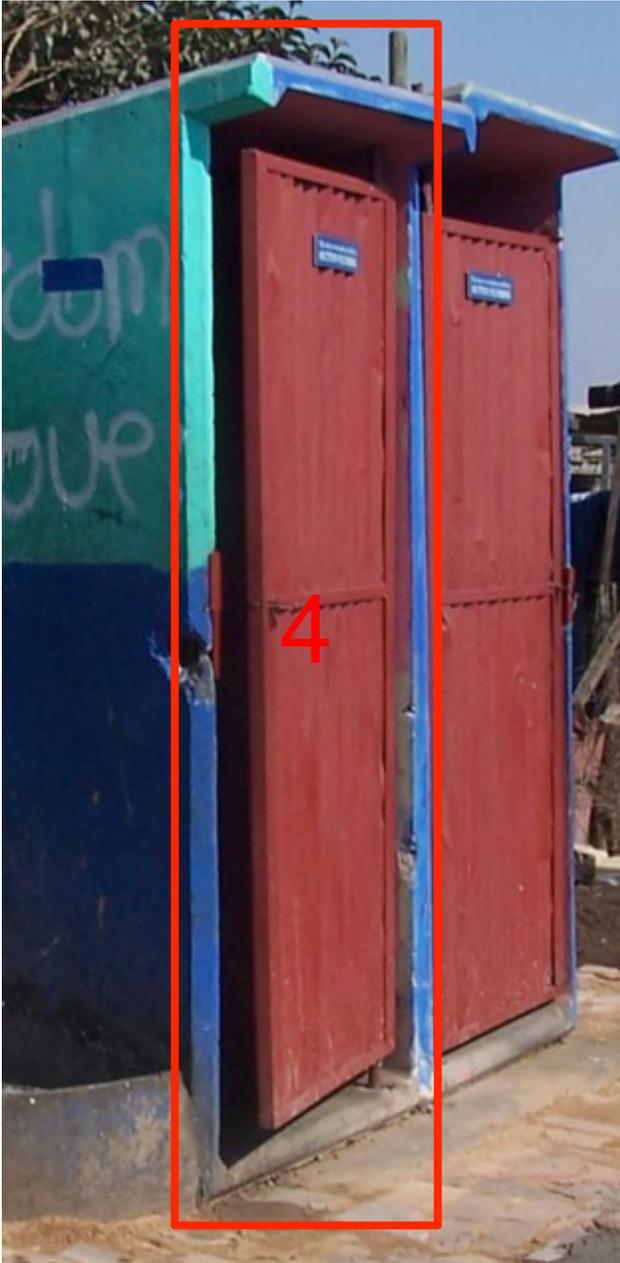
Work packages

5 Door and lock + jamb repair as needed

Door and lock

Jamb reinforcement
