COMMUNITY PLUMBING CHALLENGE 2016 DIEPSLOOT

DATA FOR HEALTH HARDWARE

COMMUNITY PLUMBING CHALLENGE 2016 - 8 NEW TOILET UPGRADES

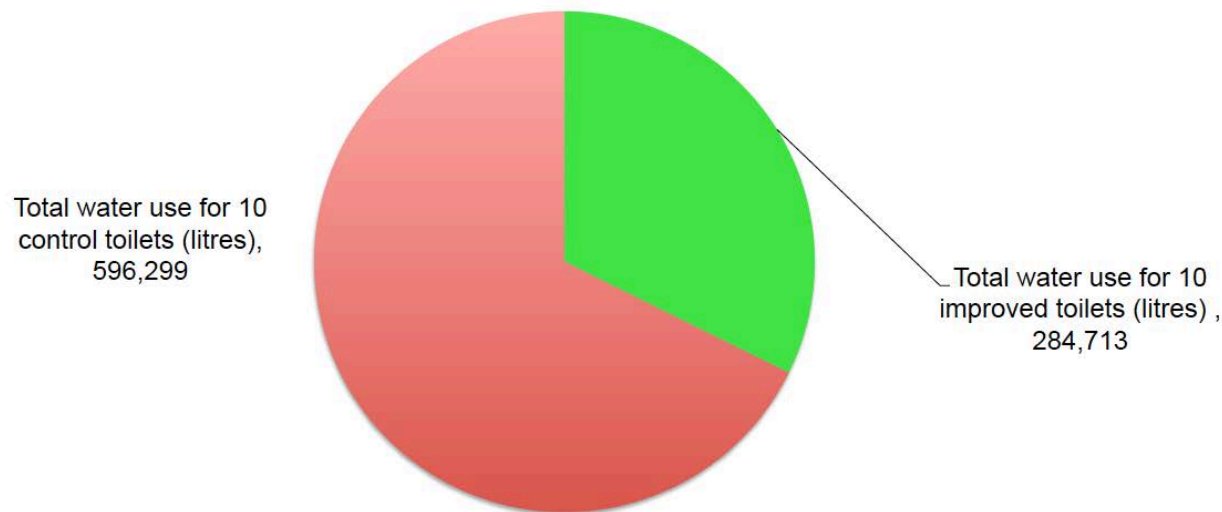
WASSUP Diepsloot Sanitation Project Total water use

Total water use in the improved toilets and tap points as compared to the control group, only 16 days after the works were commenced, this graph shows the **dramatic improvement in water saving whilst improving access to the facilities.**

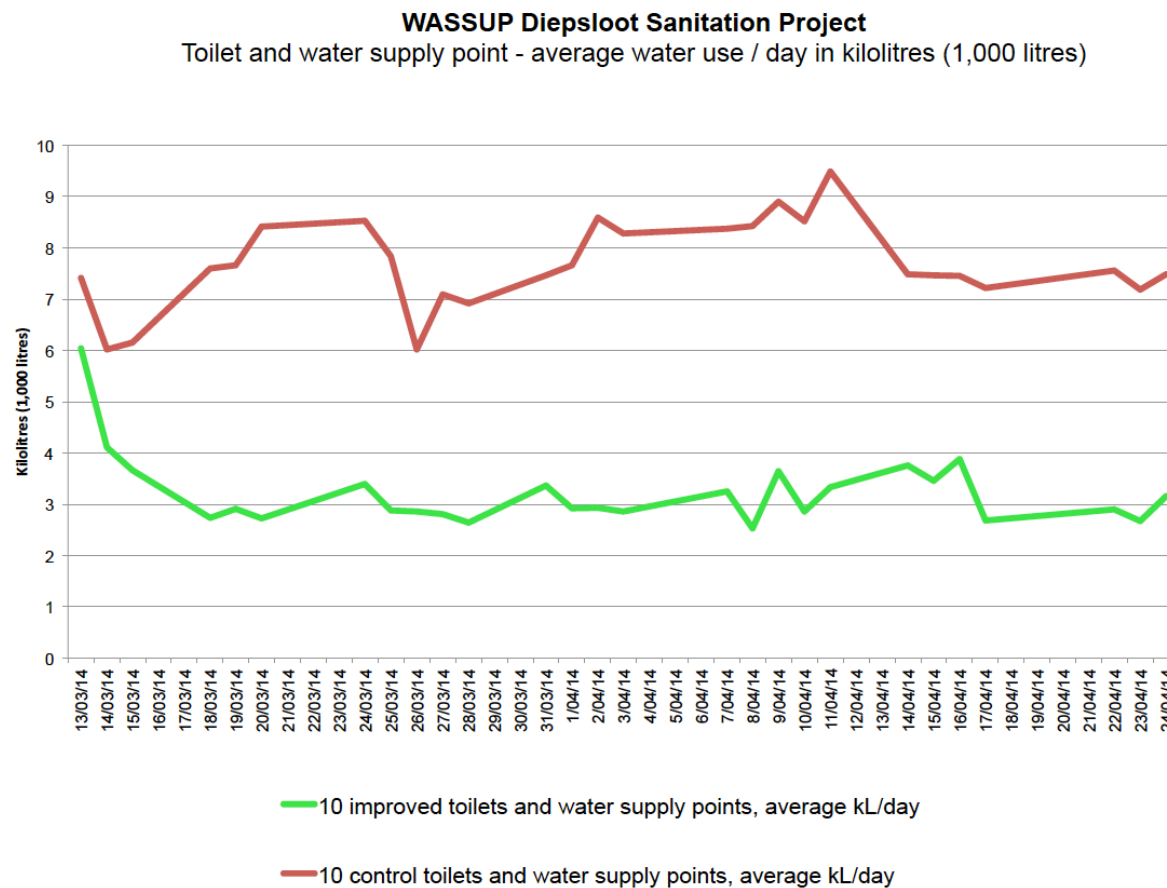
Water use – average volume used per toilet and tap point every day – improved / control

After only 42 days, the water meter readings show the difference between the improved toilets/ tap points and the control group, with an average difference per toilet of over 4,000 litres per day. This could mean around 13 million litres of wasted water a day passes through the other 110 toilets being managed by WASSUP if the poor existing hardware is not improved.

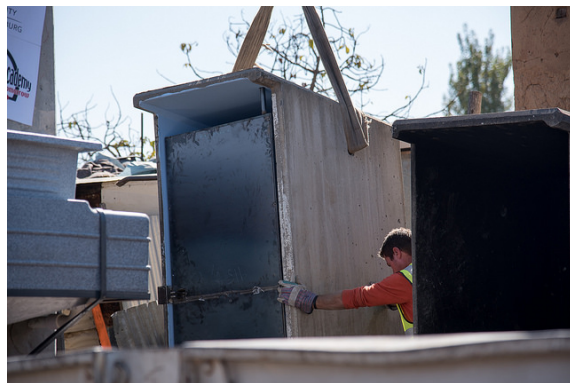
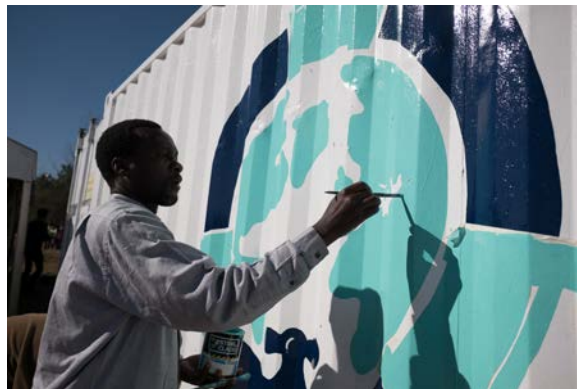
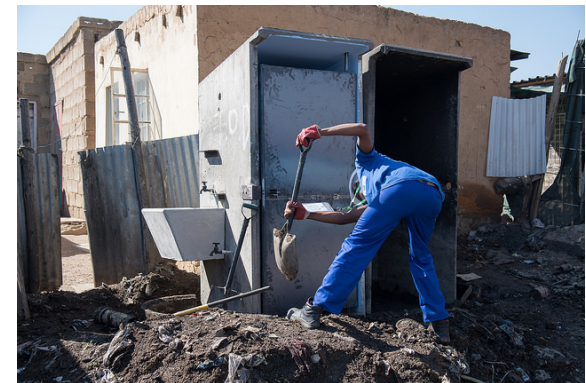
Eight **defunct communal toilets were plucked out** of the ground in Diepsloot Extension 1, (and replaced with new and improved toilets as upgraded by the WASSUP team) where four international student teams (representing Australia, India, United States and South Africa) will now collaborate to develop the most effective and sustainable new upgrade solutions.

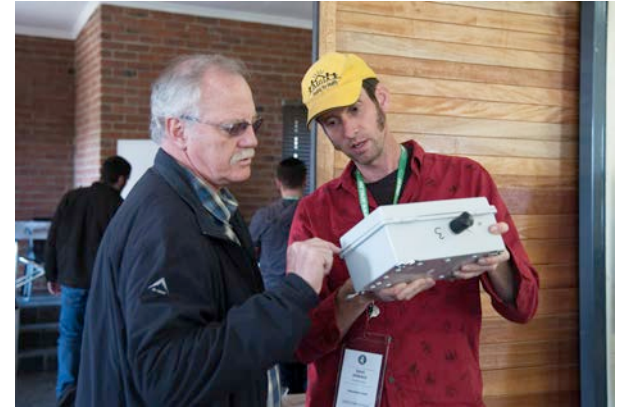
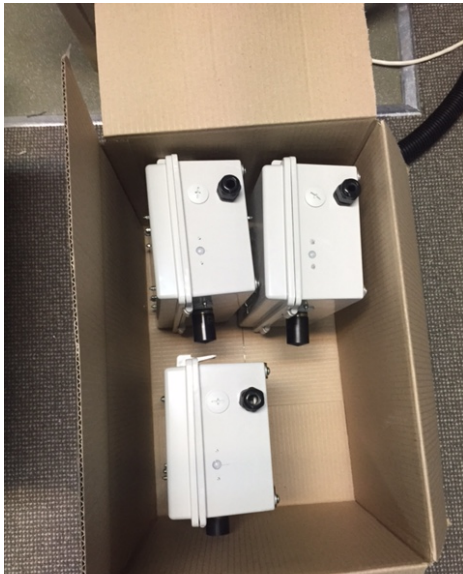
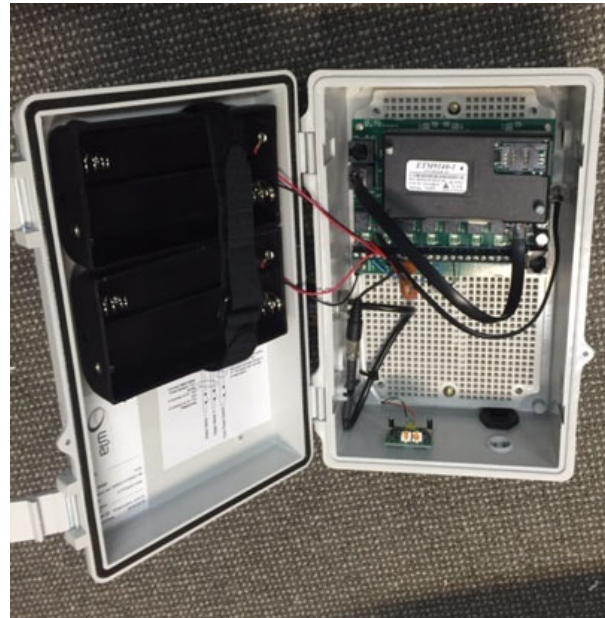
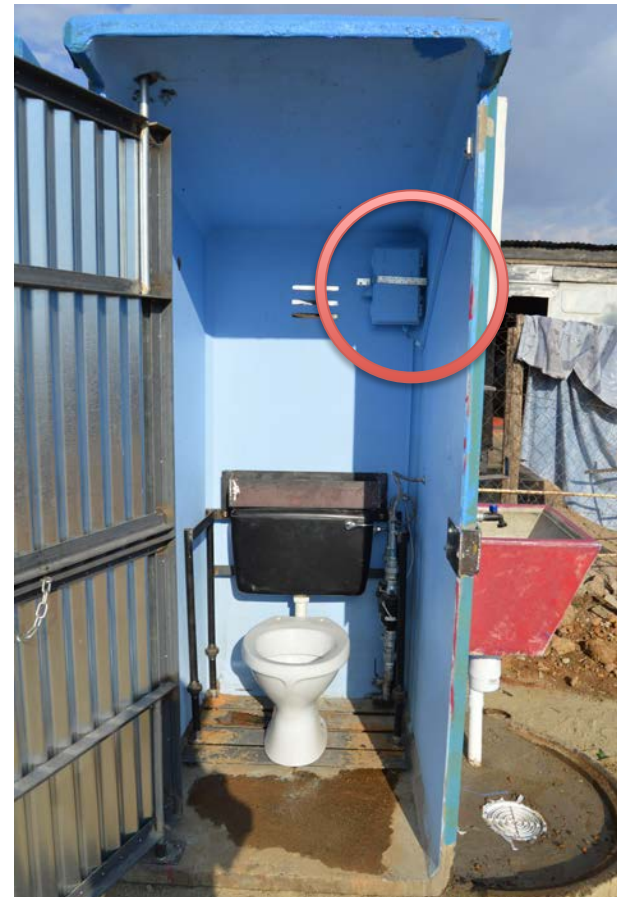
CPC – THE LOGGING EQUIPMENT

Designed to travel and install easily, the loggers record data every 5 minutes or when door opens.

- Door opening
- Door state
- Presence
- Tap water use
- Cistern water use

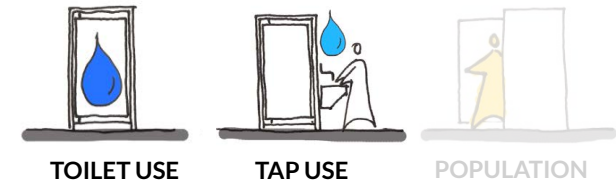
DAILY SUMMARY OF CPC UPGRADED TOILETS

After the upgraded toilet units were installed, the data loggers recorded the following daily summaries of use for each toilet:

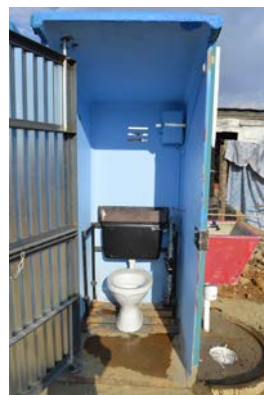
TOILET C142

Population of use to CPC upgraded toilets 2016

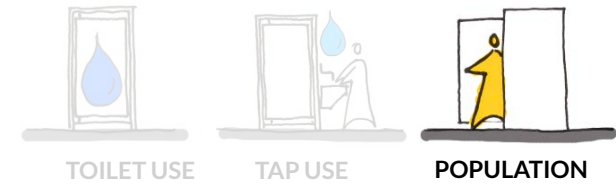
DAILY SUMMARY OF CPC UPGRADED TOILETS

After the upgraded toilet units were installed, the data loggers recorded the following daily summaries of use for each toilet:

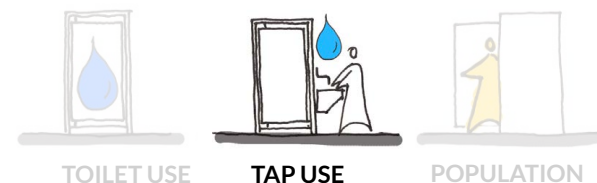
Analysis #1

1. Tap event not associated with toilet use
2. Tap event not associated with toilet use
3. Toilet use
4. Door Event with toilet use followed by tap use followed by toilet use followed by tap use assumption is that tap use is associated with toilet use
5. Toilet use not followed immediately by tap use - assumption is that no hand washing occurred

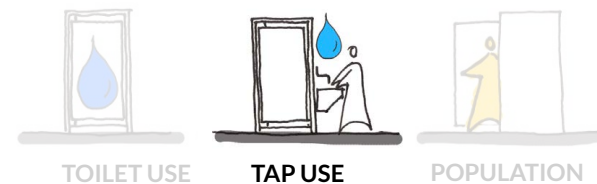
Analysis #2: hand washing vs. water supply

1. Toilet use - no tap use, assumption no hand washing occurred
2. Tap use likely for filling container or washing not related to hand washing
3. Tap use following toilet use likely hand washing
4. Toilet use with no tap use
5. Tap use with no toilet use
6. Toilet use with no tap use - assume no hand washing occurred

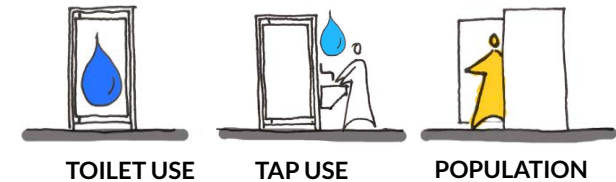
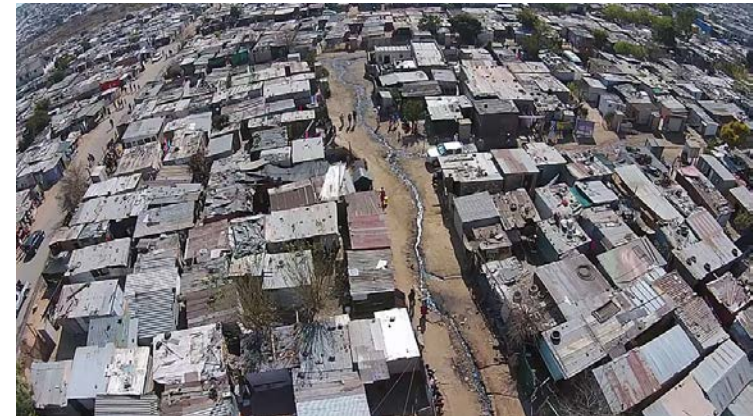
DAILY SUMMARY INSIGHTS AND POTENTIAL

- there can be a large difference in people usage across the toilet units.
- the Litres/person for toilet use is relatively consistent across all toilets, at average 4L/P.

- greatest usage is through the tap, with most of this used for water supply, not hand washing
- whilst the usage varies between toilet units, the proportion of toilet usage vs. water supply is relatively consistent.

- the average daily water usage on the CPC 2016 upgraded toilets is well below the average water usage recorded for the non-upgraded toilets (refer to 2014 data).

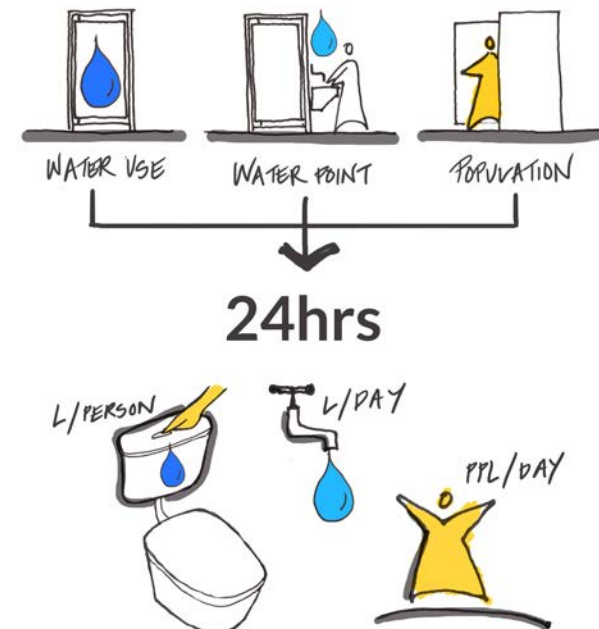
LIVE DATA

Participating teams and the local WASSUP team can monitor the upgraded toilets performance remotely.

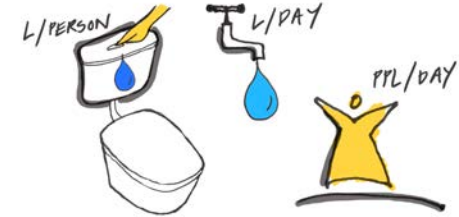
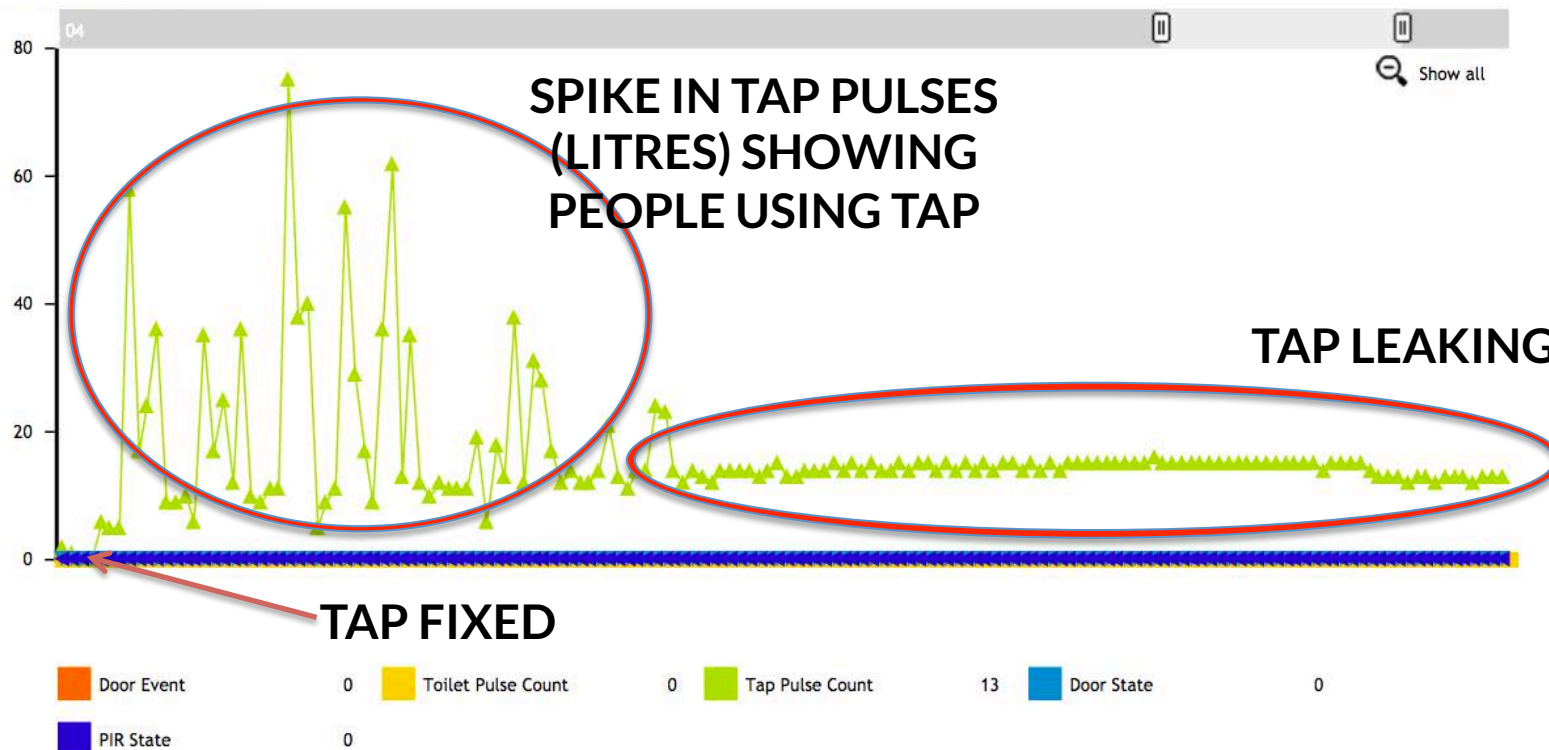
CASE STUDY LEAKY TAP

The use of logging for maintenance was realised when a change in the pattern of tap usage was while the system was still being tested.

- The leak found via the data
- An email sent to Sticky Situations in Johannesburg to investigate
- Sticky Situations contacted WASSUP in Diepsloot
- **WASSUP fixed the tap**, which was losing approximately 70 litres per hour

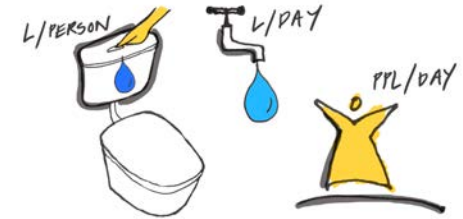
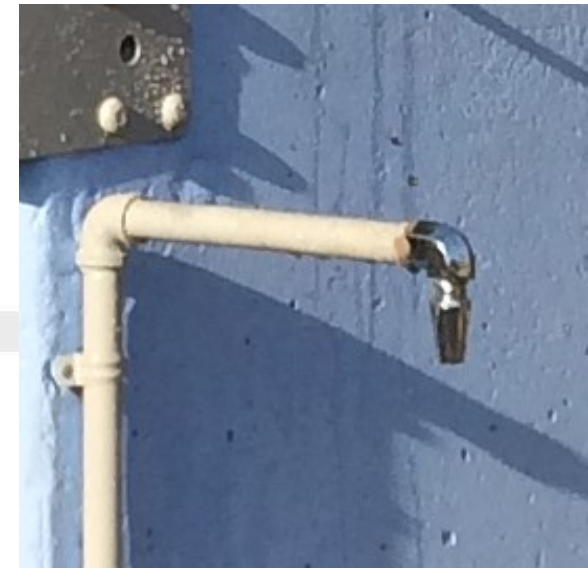
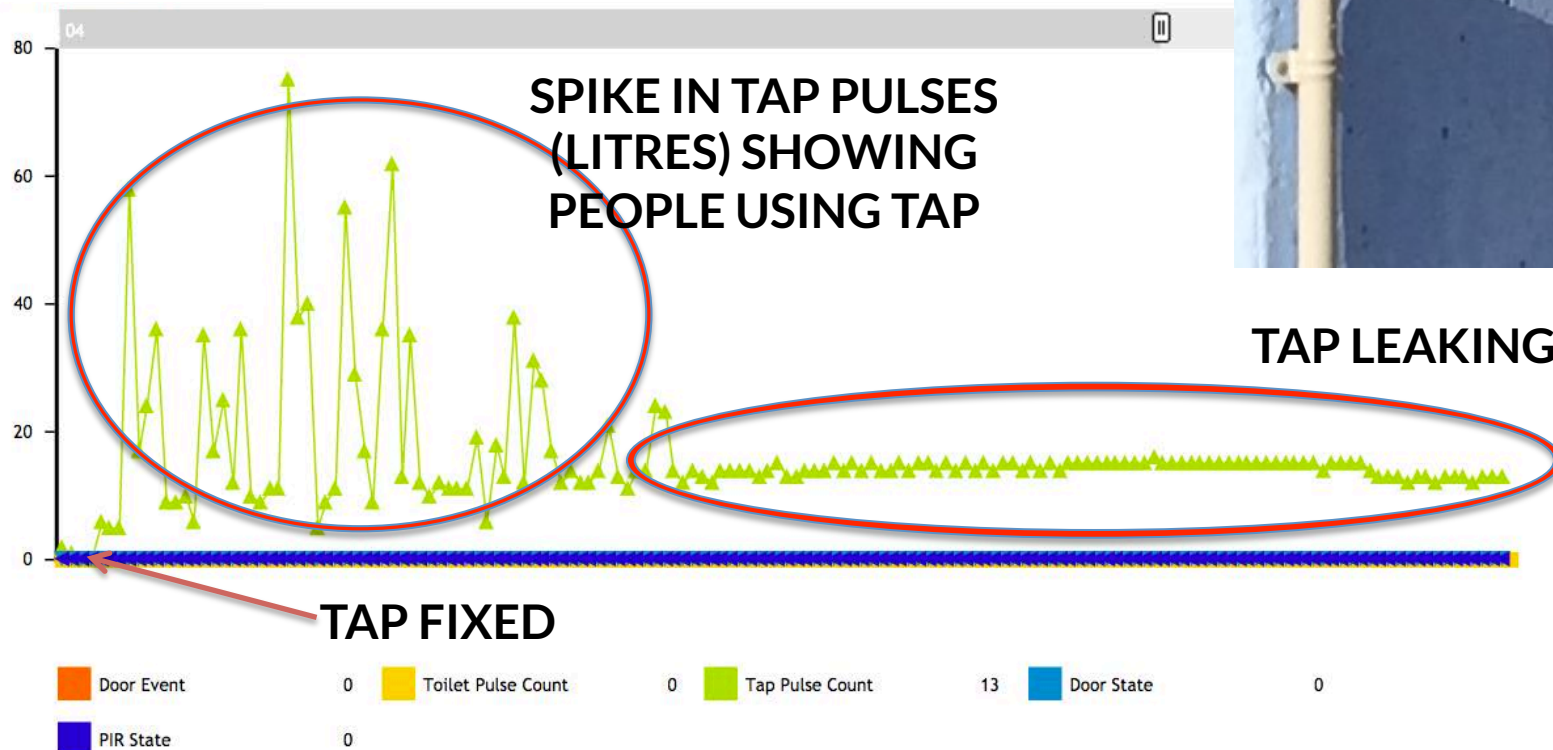
CASE STUDY LEAKY TAP

- 'Push-up' tap wasn't releasing back into the shutoff position.
- New ball-valve tap installed.

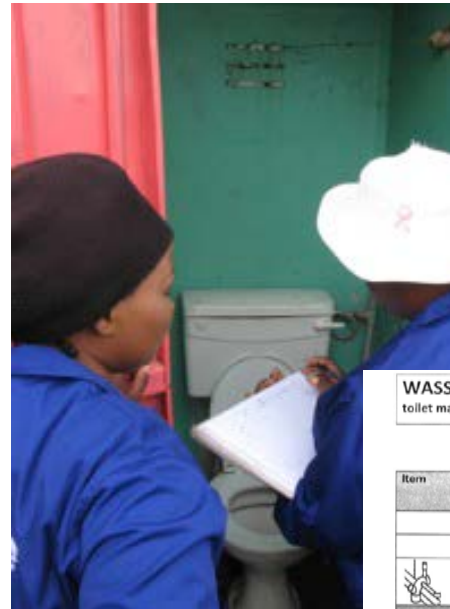
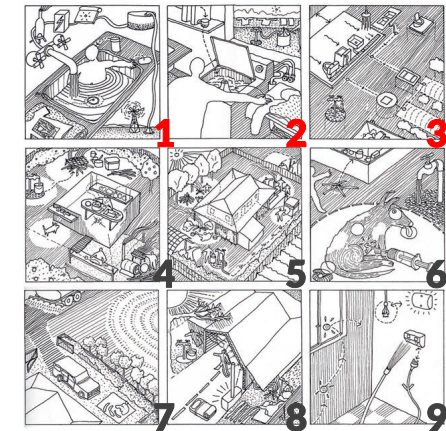
WASSUP survey & fix toilet maintenance sheet		Completed by (name): Date: 15/08/2016		TOILET NO. F35
Scores: Circle 1 for YES it is OK, or circle 2 for NO it is <u>not</u> OK or as directed by the question Fixed: tick box if fixed at time of survey

Item	Description	Score	Fixed	Test
	1.1 Water available	2		Is water connected and working at the time of survey? 1=yes 2=no
	1.2 Water pipes OK	2		Are the water supply pipes OK with no leaks? Are they fixed well to the walls? 1=pass 2=fail

2.1 All waste water OK	2		1= all OK and no obvious smells, 2=pools of waste water around or inside the toilet, or waste leaks?
	2.2 Drain waste pipes OK	2		Are the drain pipes OK with no cracks or holes? Is the vent pipe OK? 1=pass 2=fail

3.1 Door lock OK	2		Check if the door locks inside and outside, and allows privacy OK? 1=pass 2=fail
	3.2 Door OK	2		Check door and hinges: no holes, privacy OK and hinges are secure? 1=pass 2=fail

4.1 Walls, roof, floor OK	2		Are the walls, floor and roof cracked? No holes then OK? 1=pass 2=fail
	4.2 Floor: grade to drain water OK	2		Use ball in toolbox to check grade: 1= water on the floor would flow to a floor waste ok and the floor has enough fall to prevent pooling of water, 2= fail

5.1 Full flush test OK	1		Can 3 lengths of toilet paper be crushed, placed in the toilet and flushed away? 1=pass 2=fail
	5.2 Refill time OK	1		After flushing cistern use watch to time refill. 1=pass (must refill in 3 minutes) 2=fail

5.3 Stop valve OK	2		Can you turn the stop valve off? Does turning it off stop the water flowing? 1=pass 2=fail
	5.4 Cistern (on wall) OK	2		Is the lid OK and not loose? 1=lid is OK, securely fixed to wall, no other damage, and the cistern does not 'run on' / leak after refill. 2=fail

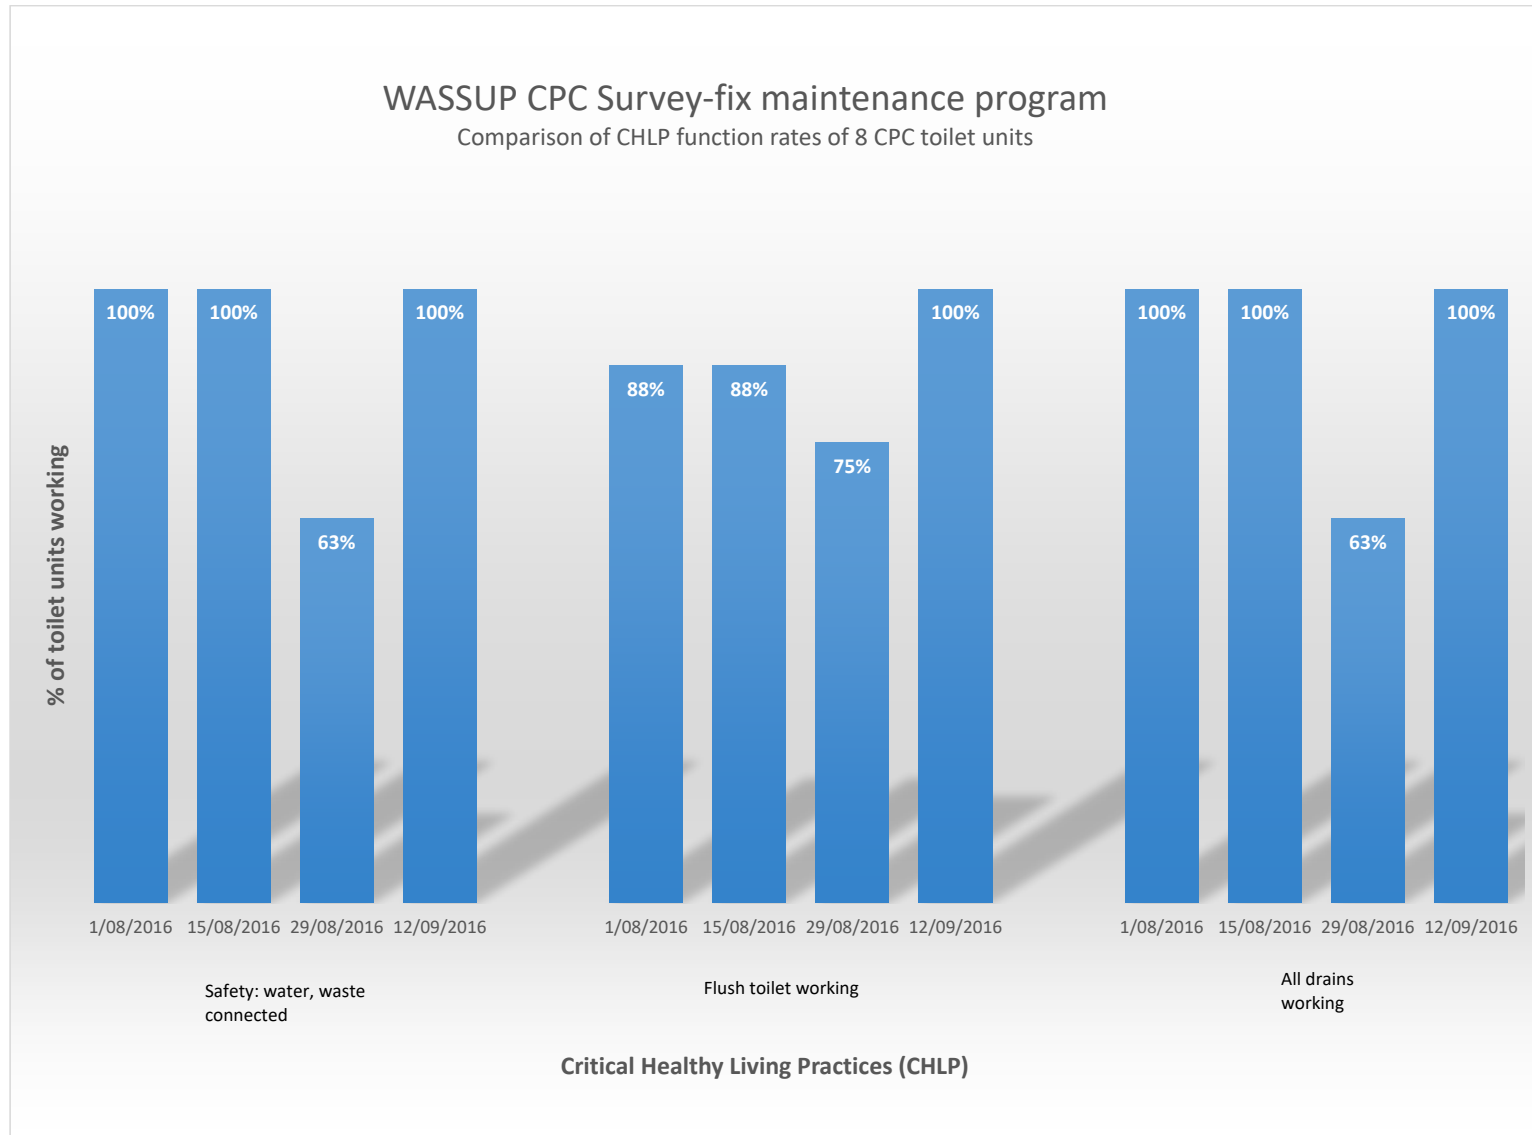
Results of Critical Healthy Living Practices

WASSUP have been conducting a fortnightly survey-fix of all 8 upgraded toilets during the CPC.

Based on the Healthy Living Practises, the most critical of these will have the biggest impact on health. The Critical HLP scores make up the following:

The fortnightly survey-fix conducted by WASSUP on the CPC toilets, are a good example of the importance of funding an ongoing repairs and maintenance program. As the team have completed their survey-fix, they have uncovered and fixed a faulty / leaking tap, a failed cistern mechanism, a blocked gully drain, and two toilet units with blocked drains to the entire unit. These failures were unavoidable, and the only way they could be fixed is through an ongoing repair and maintenance program. Left unchecked, thousands of litres of water would be lost, and more **importantly public health will continue to be compromised.**
