**Report on the
commencement
of the first
earthquake house
Bhattedanda Village
Nepal
September 2016**

HEALTHABITAT O/S LTD

Rotary / RAWCS

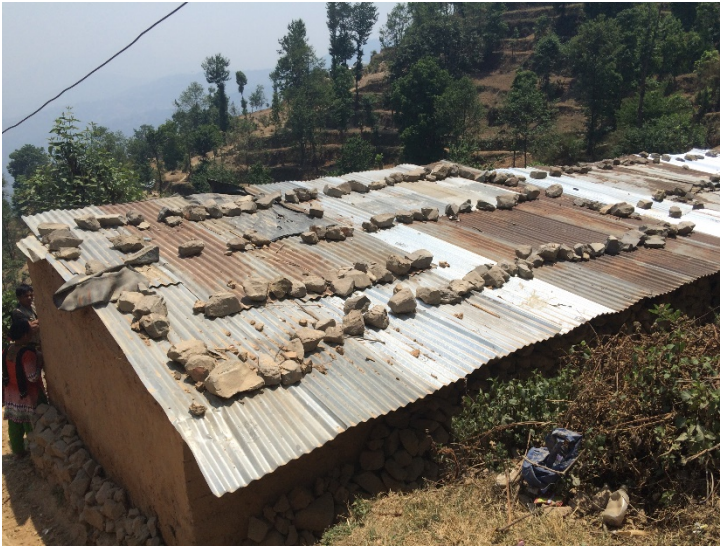
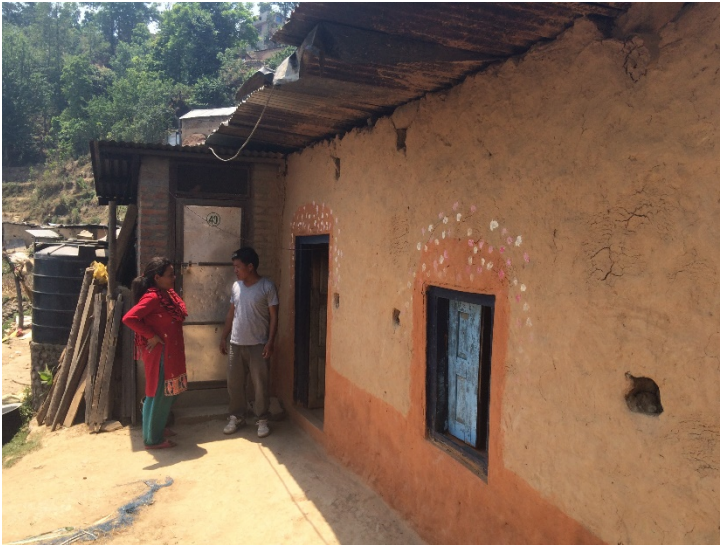
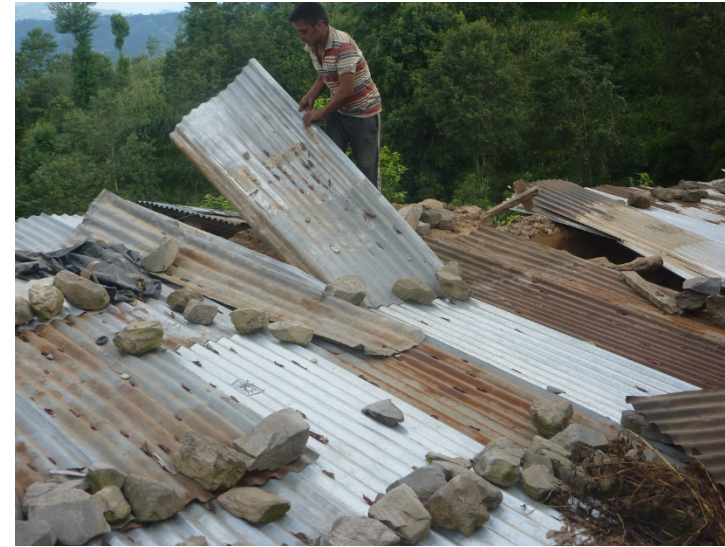
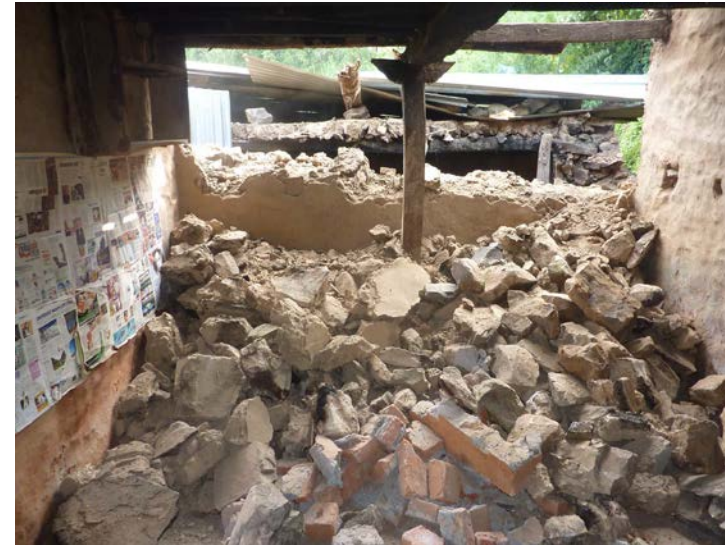
Sundar Lama's
existing family
house April
2016

The family
demolish the
remainder of
their existing
house in late
August 2016, in
preparation for
the
construction of
the new house

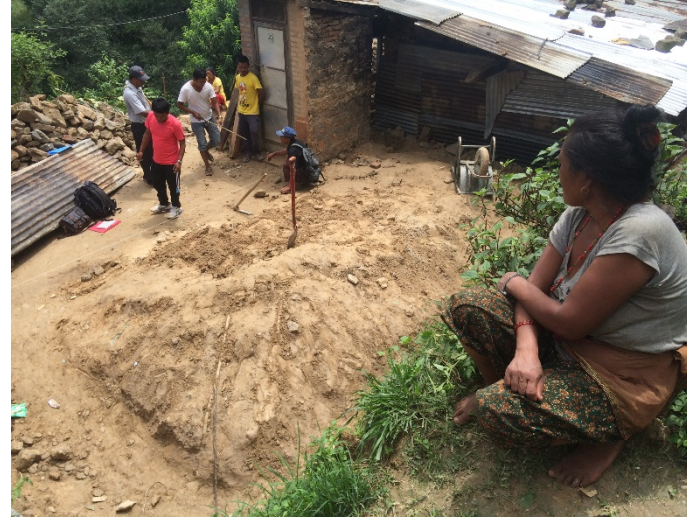
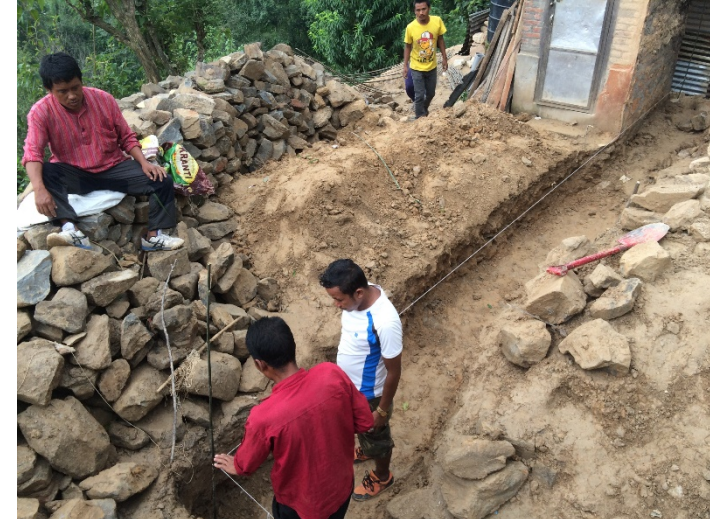
Day one of the rebuild commenced with investigation of the existing footings, which were found to be undersized. These were removed and the new footings were marked out

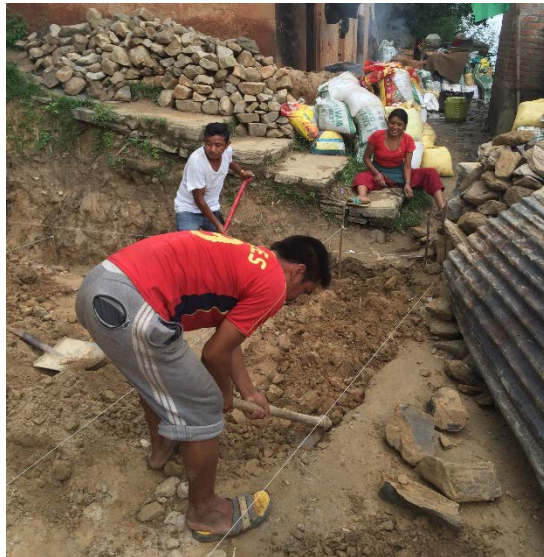
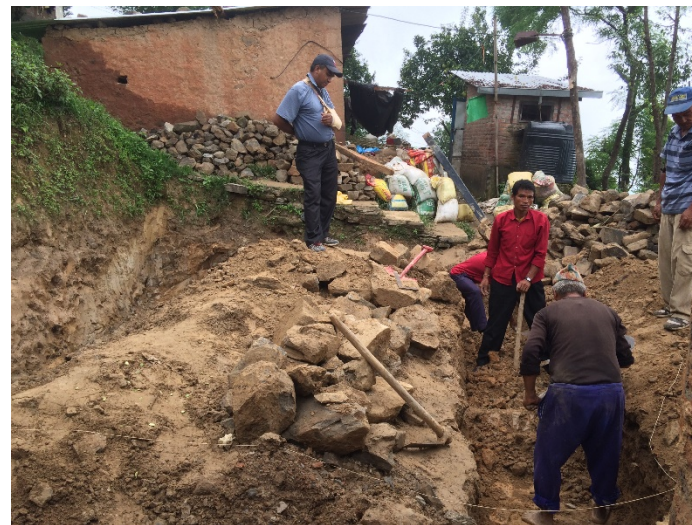
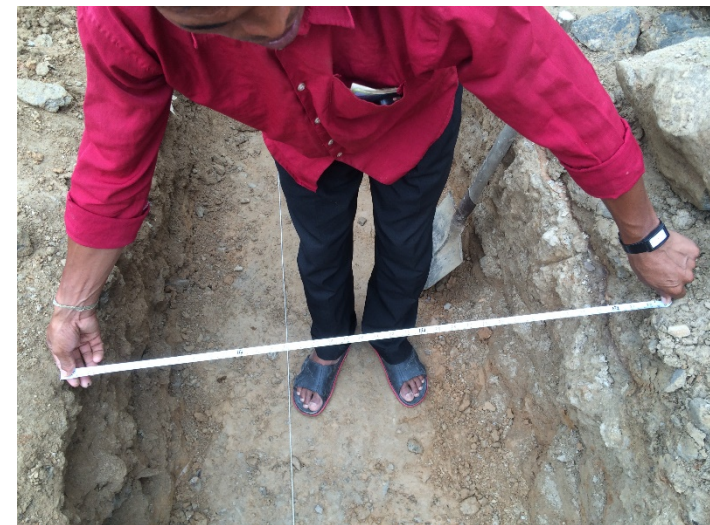
New footings were dug 2' (600mm) deep x 2'6" (750mm wide)

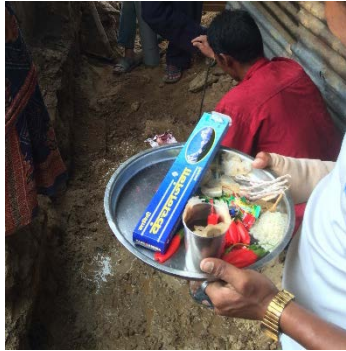
Puja (Prayer) for the foundations

A puja (prayer) for the foundations was done by the family and builders before the first stones were laid

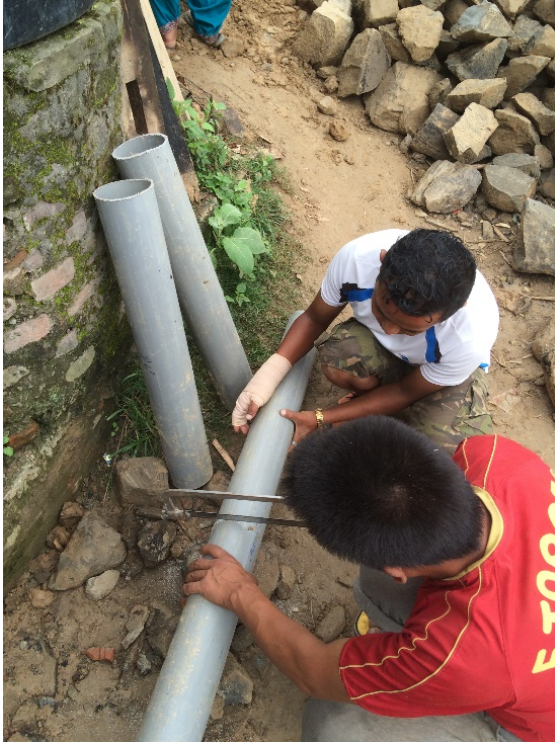
PVC sleeves are cut into 2'6" lengths (750mm)

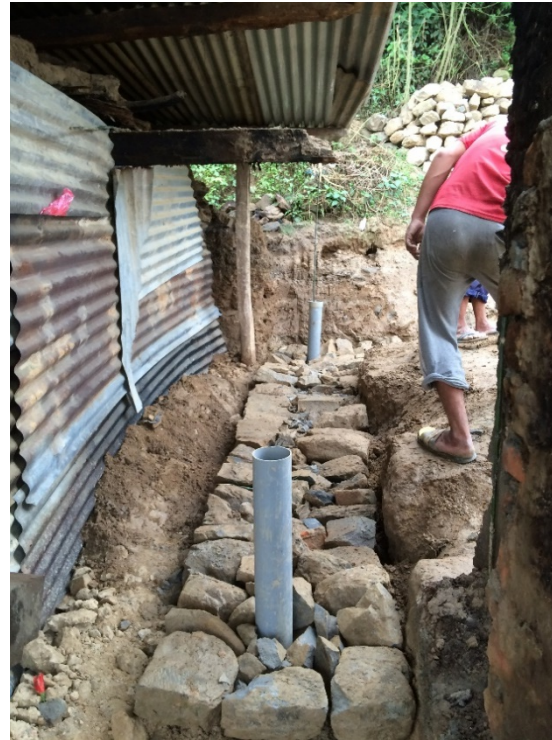
Sleeves are set 1'6" (450mm) into foundations at corners, wall junctions and adjacent all doors

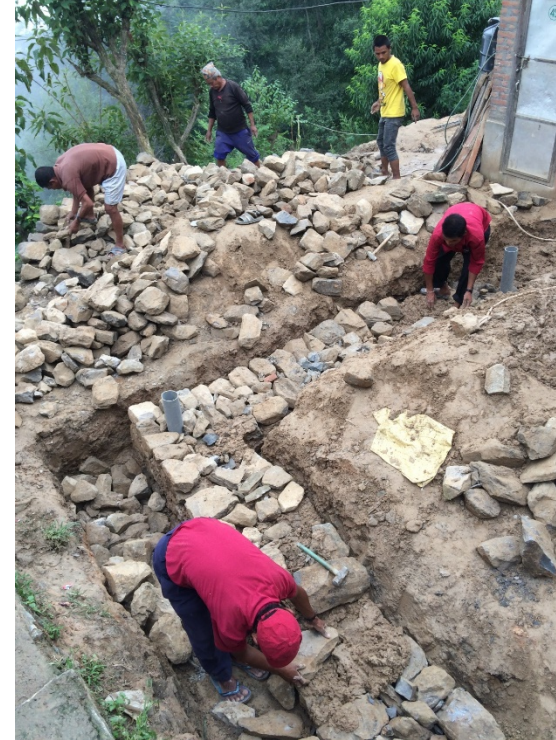
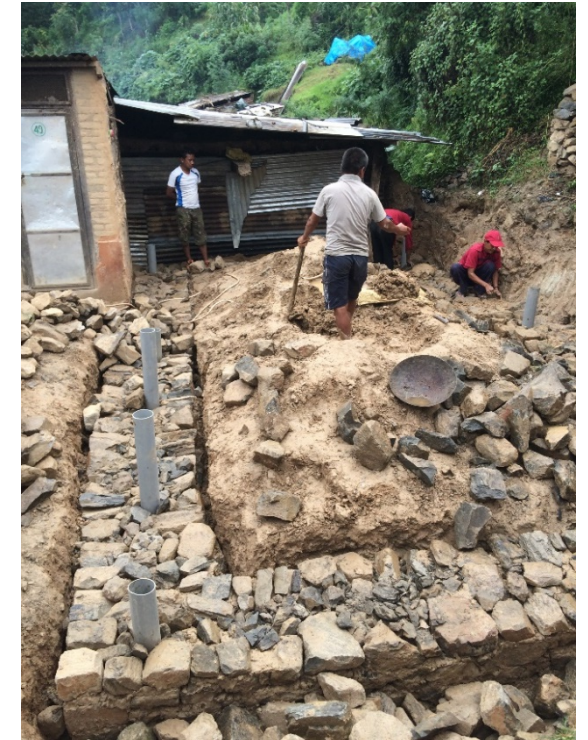
The stone and mud foundations are built up to ground level. Vertical 10mm deformed bars are set into the PVC sleeves as the concrete on the first earthquake band is poured

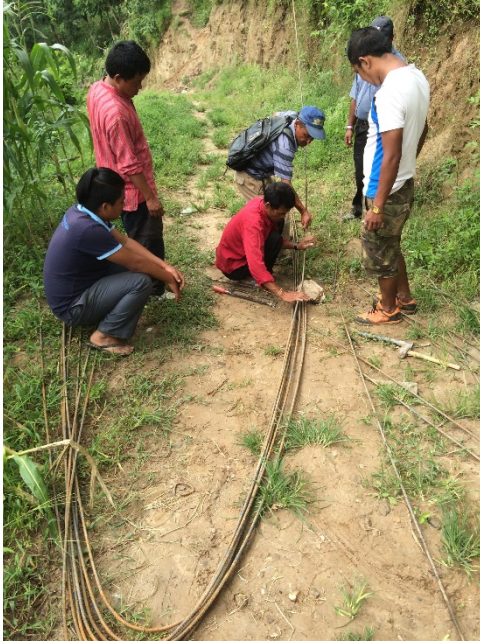
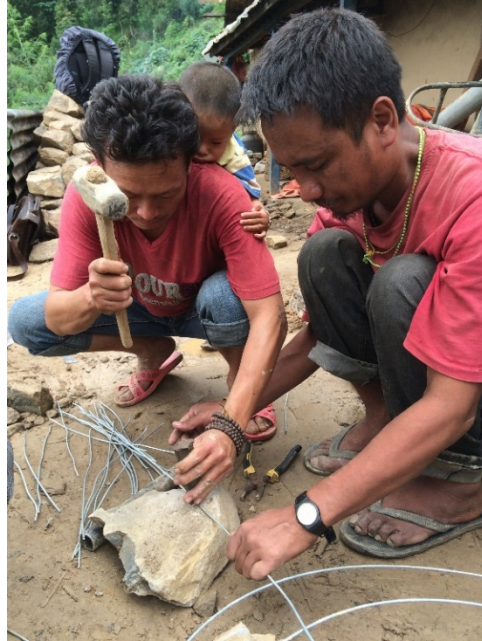
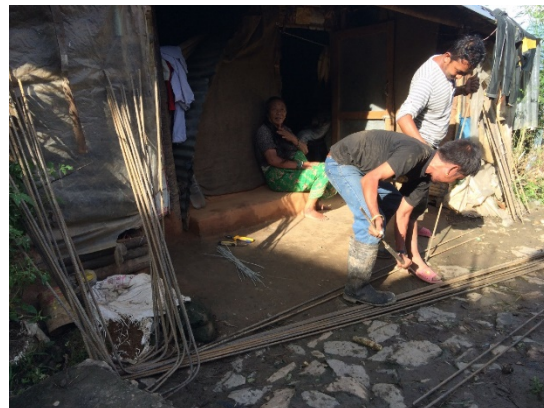
With a hacksaw, chisel, hammer and plyers the steel reinforcing ladders for the first earthquake band is prepared

The first earthquake band is made with 2 x 10mm deformed reinforcing bars, tied with 3mm galvanised wire.

Additional reinforcing is added to the corners

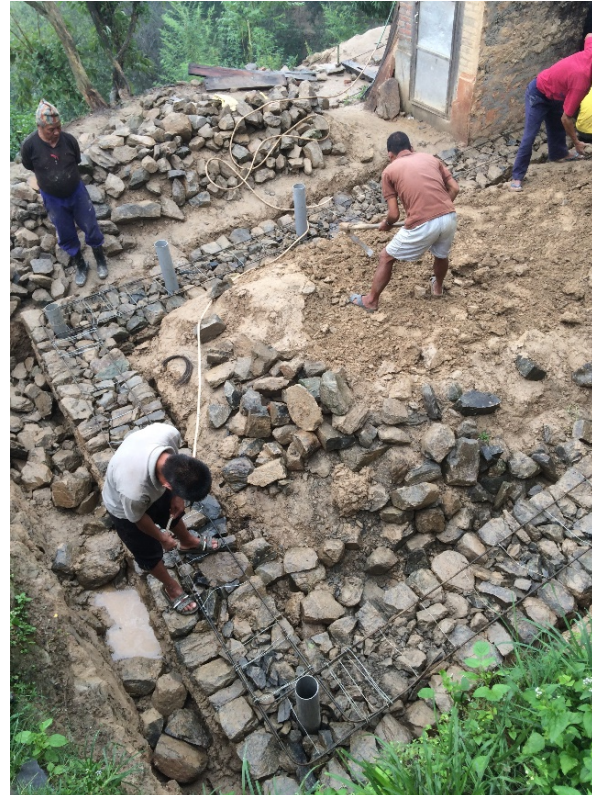
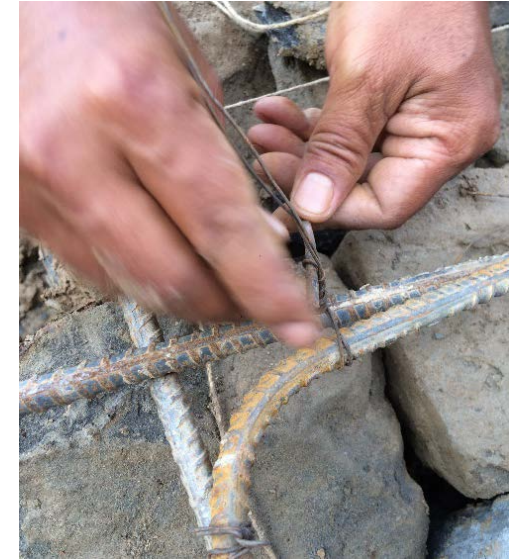
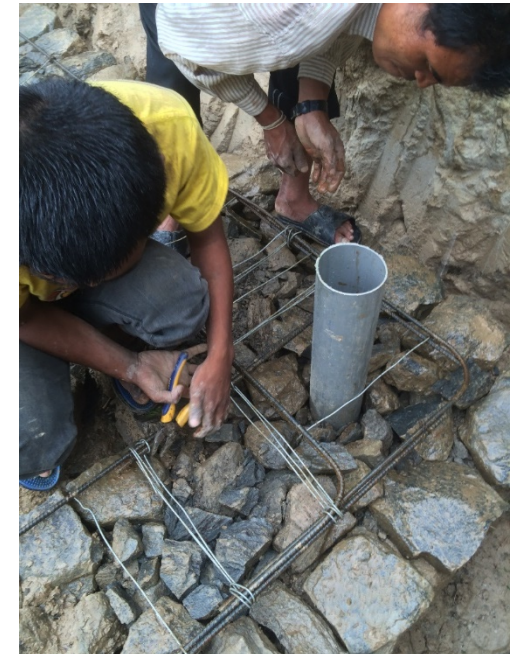
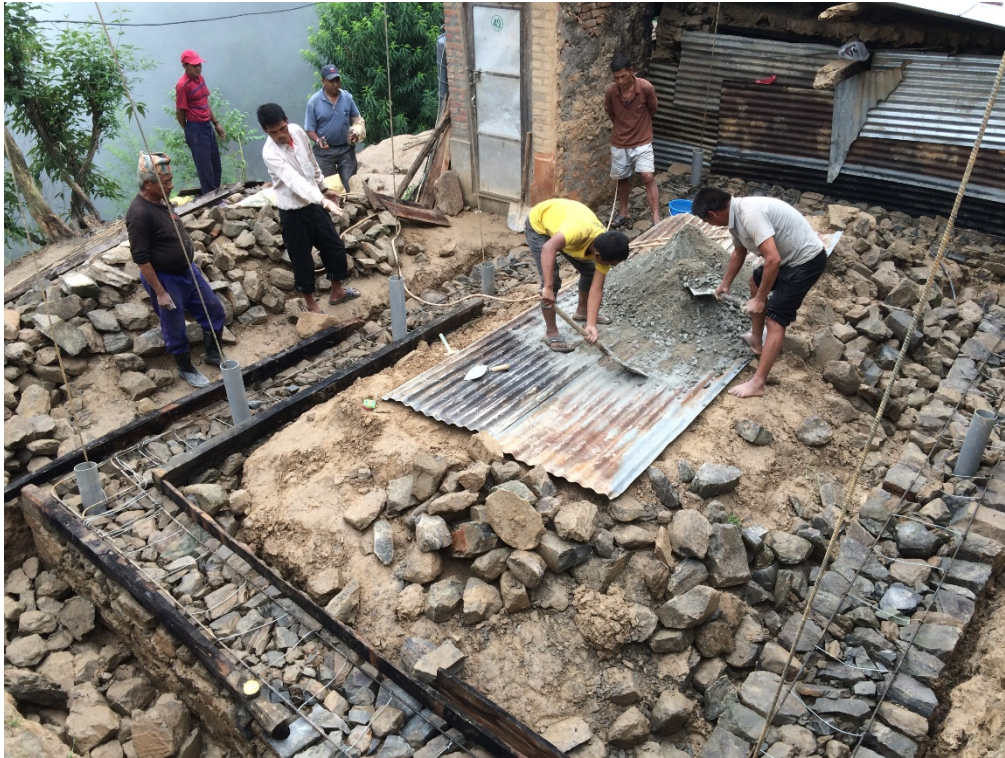
The first perimeter earthquake band

The top layer of the foundations are washed clean, the horizontal and vertical steel reinforcing is placed into position, and the formwork is installed

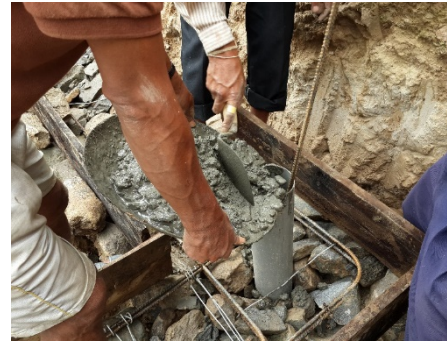
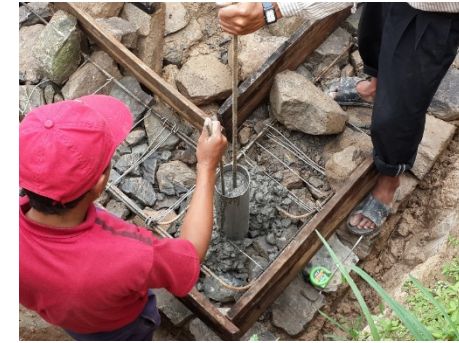
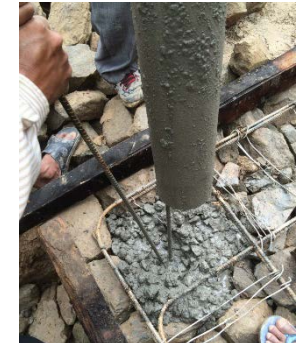
The PVC sleeves are lifted as concrete is poured down the hole surrounding the vertical bars, filling the spaces between the stone

A little detergent is added to the mix to help the mortar flow down into the spaces between the stones

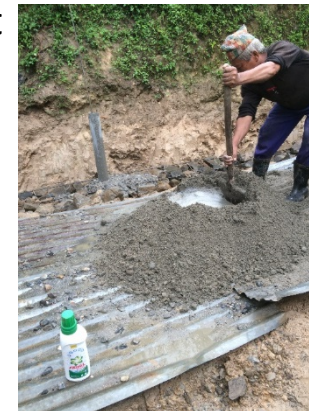
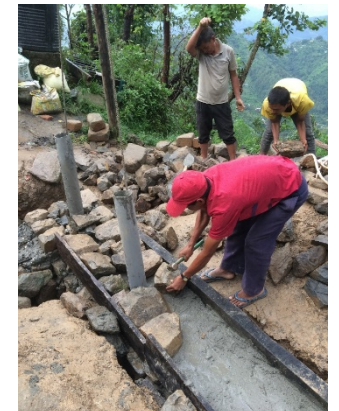
Concrete is poured for the band, and the first layer of stones are immediately set into position

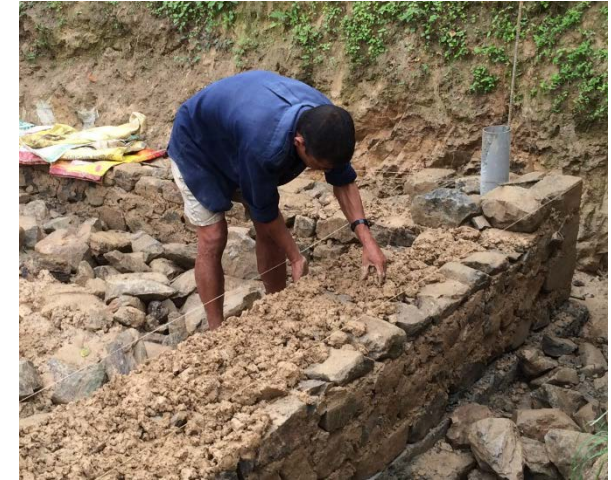
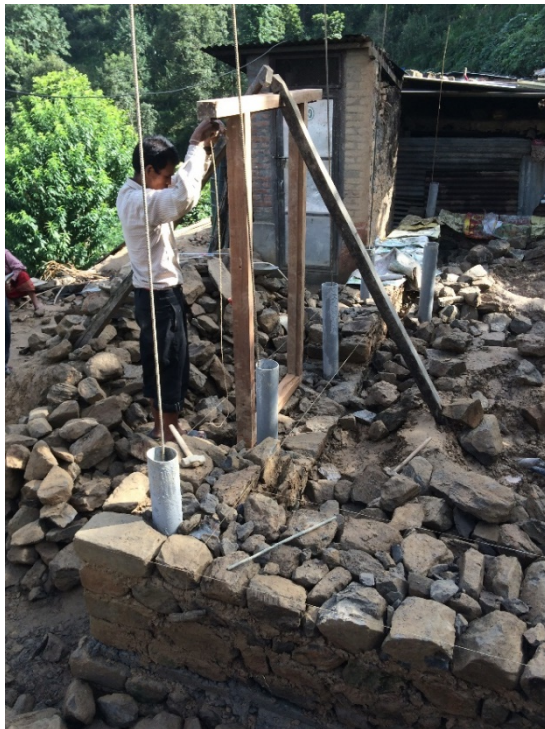
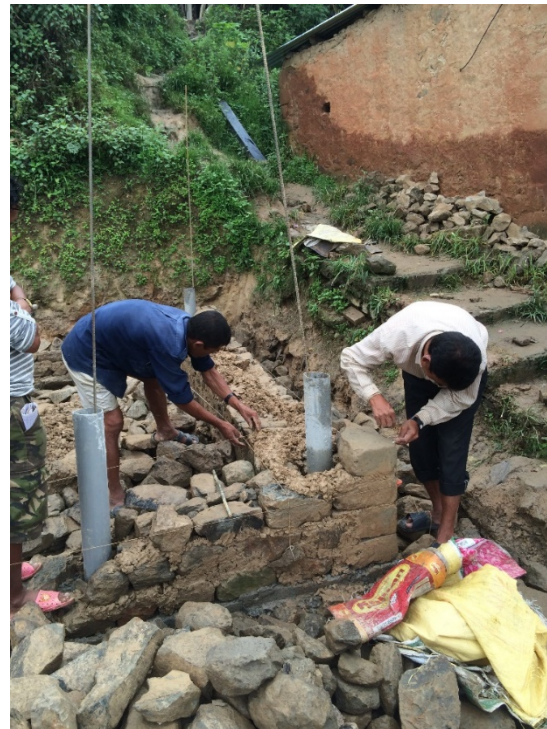
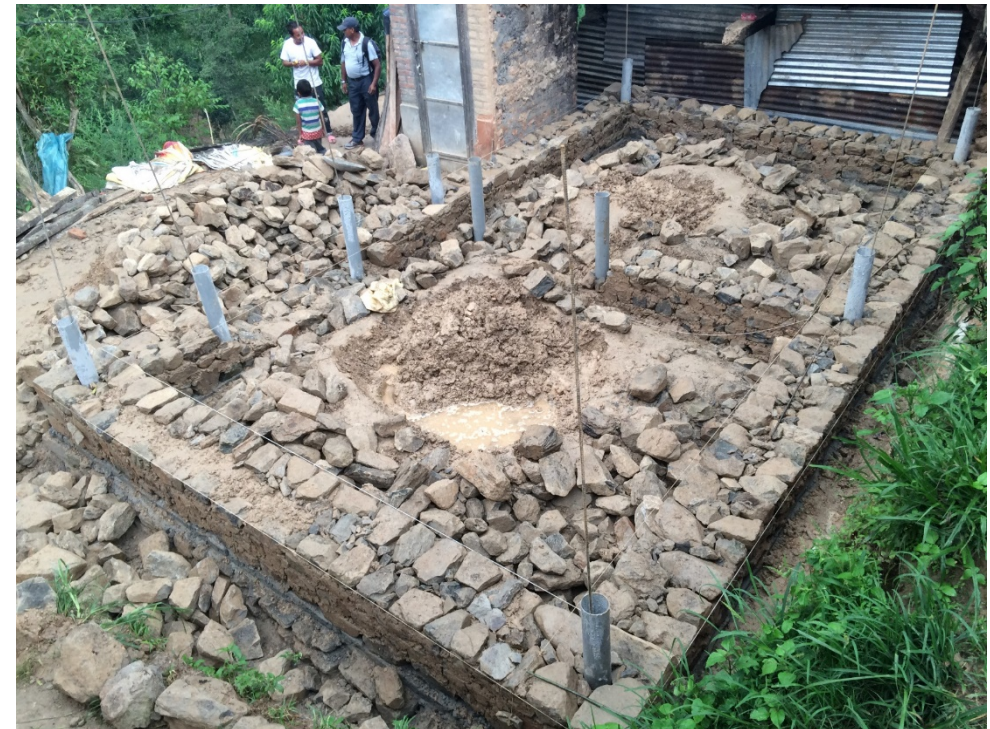
Work commences on the first 2' (600mm) of stone wall.
A new front hardwood door frame is built and installed, and the original corner stones reinstated.

A layer of
mud mortar
is laid
between
stone
courses

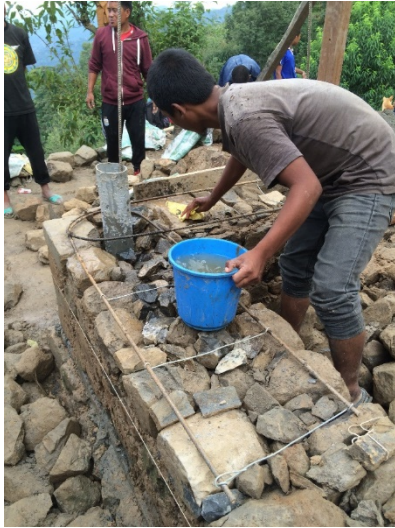
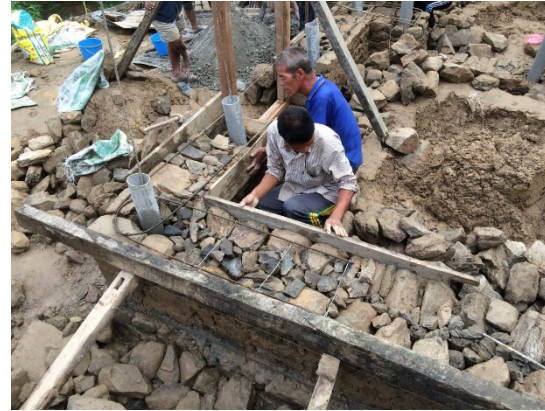
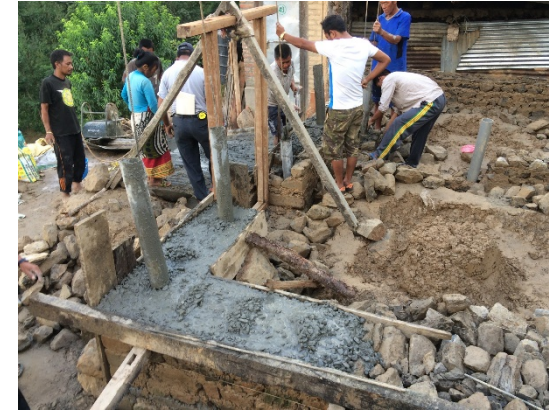
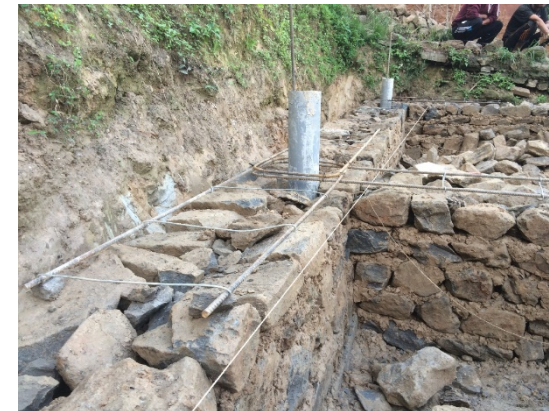
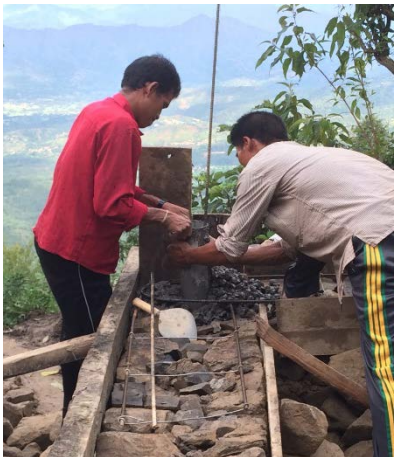
Reinforcing of the 'L' corners and 'T' wall junctions

The top layer of stone is again washed to ensure bonding of mortar
